# **Dixon Engineering, Inc.**

Preliminary Maintenance Inspection

1,250,000 Equalization Basin B

Leesburg, Virginia

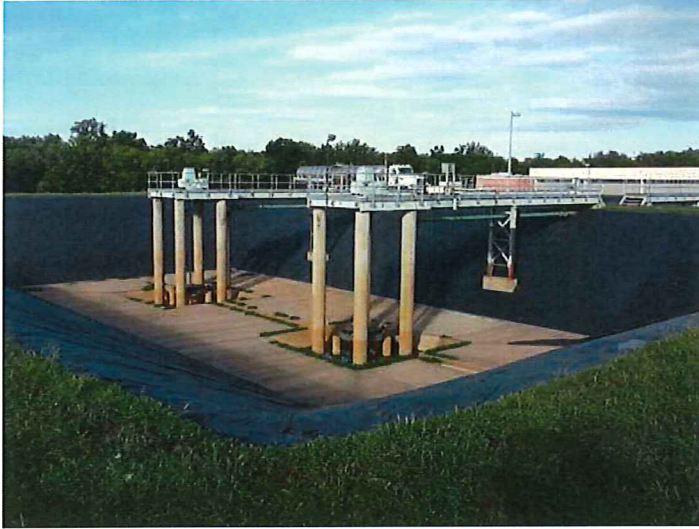
1) Equalization basin B with rubber liner

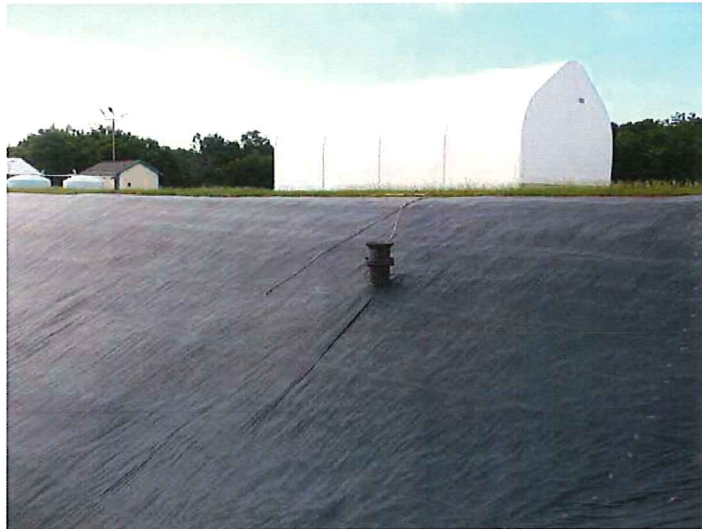
2) Same.

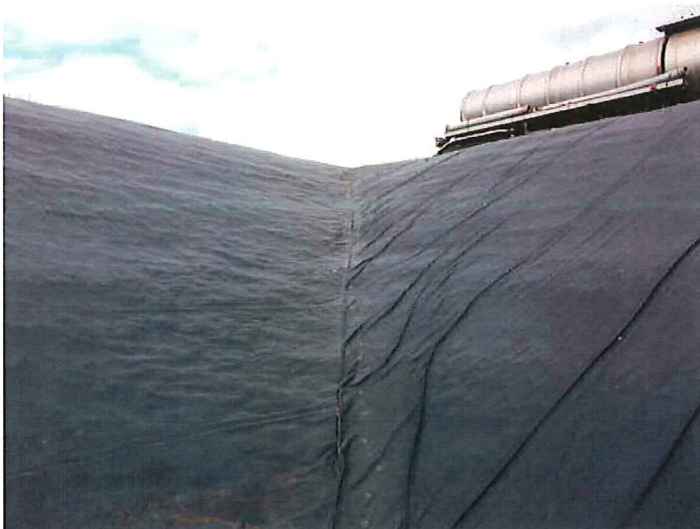
3) Same.

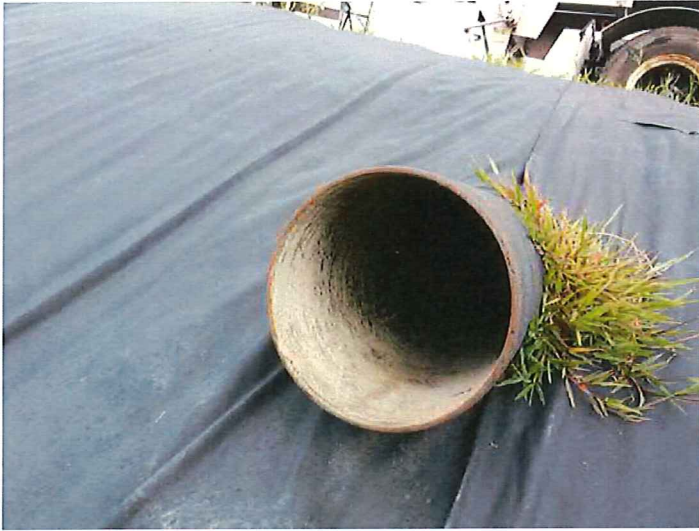
4) Pipe penetration in liner with vegetation growth.

Install a new 45 mil thick rubber liner on the interior sloped dirt walls. Secure edges of the liner at the concrete floor with aluminum straps and anchor bolts. Liner seams on the slope should be heated and fused together with a liquid sealant. Liner edges at the top of the walls should be buried. The estimated cost is \$50,000.

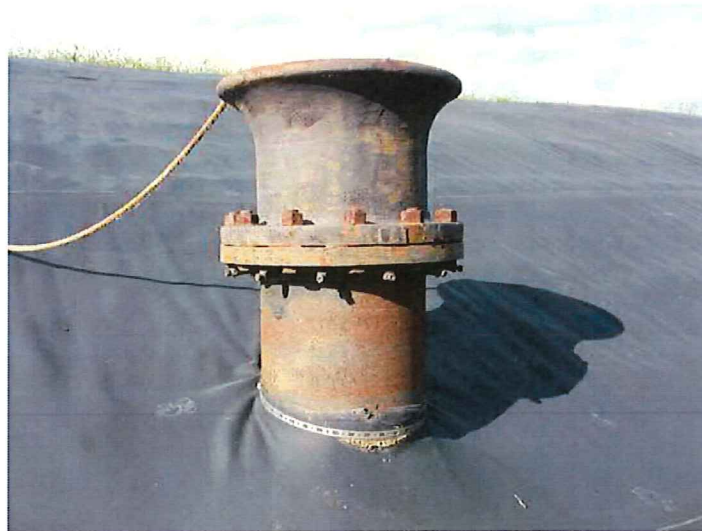
5) Same.

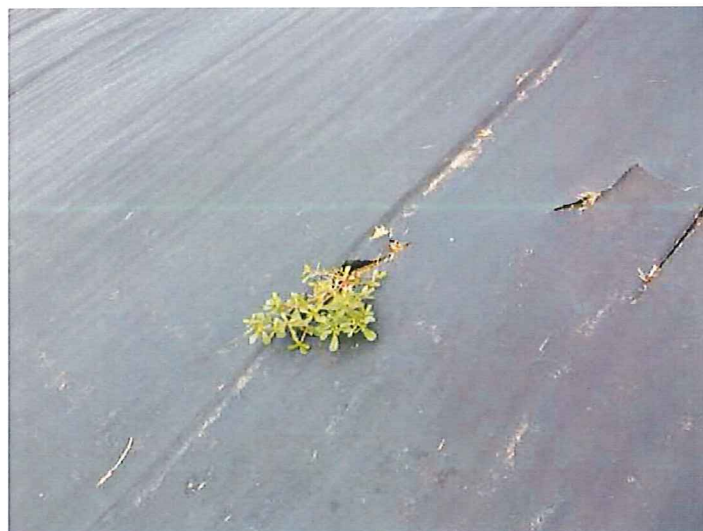
The wet interior is lined with a rubber liner that covers the sidewalls and is in fair condition with numerous rips and other damage. The bottom edge of the liner is secured with aluminum strips and bolted into the concrete. There are a few of the bolts that are missing. The vertical seams of the liner have been heated and sealed together. The top edge of the liner has been buried.

6) Tears in liner.

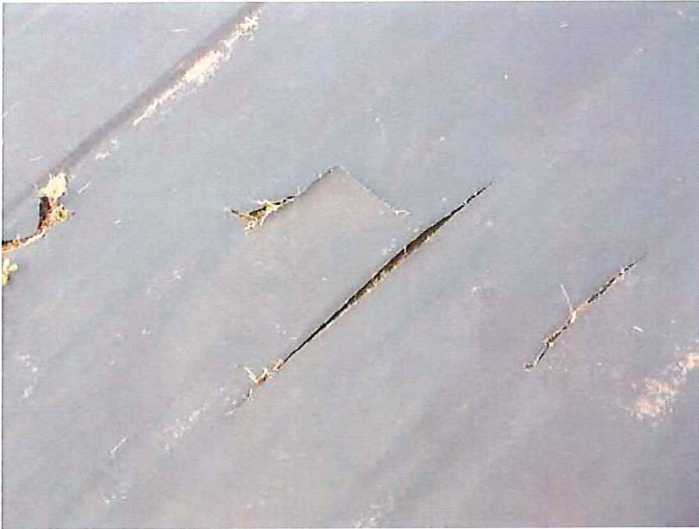
7) Same.

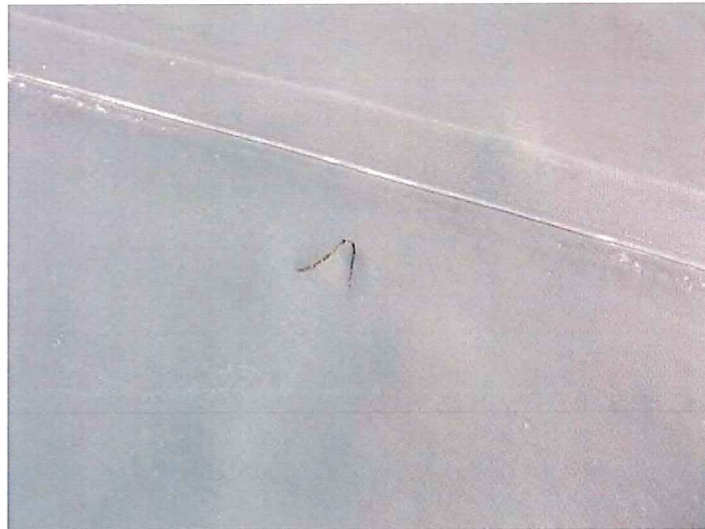
8) Holes in liner.

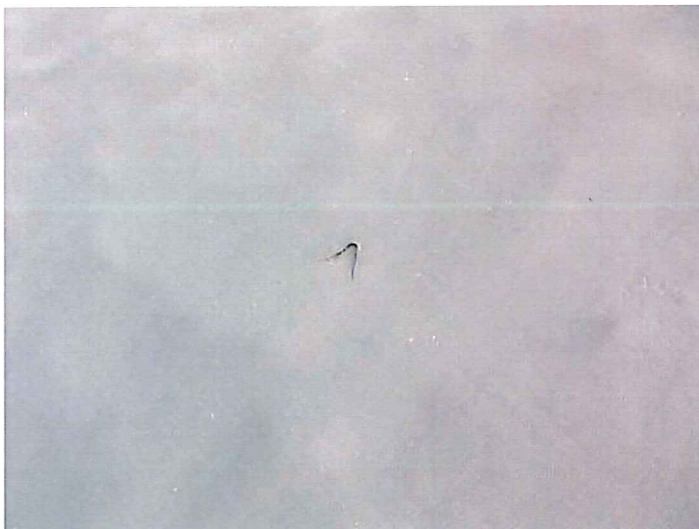
9) Same.

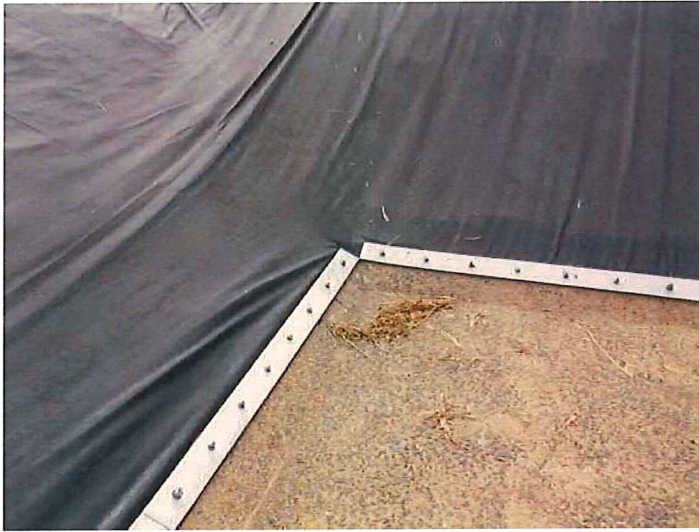
10) Aluminum strip securing bottom of liner.

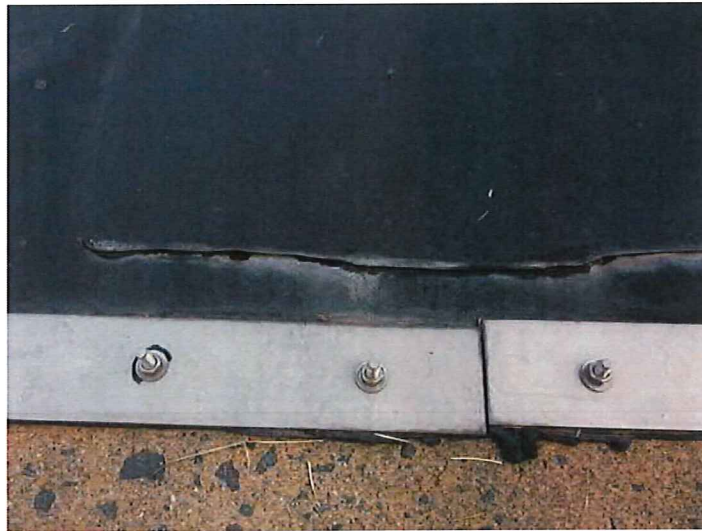
11) Same.

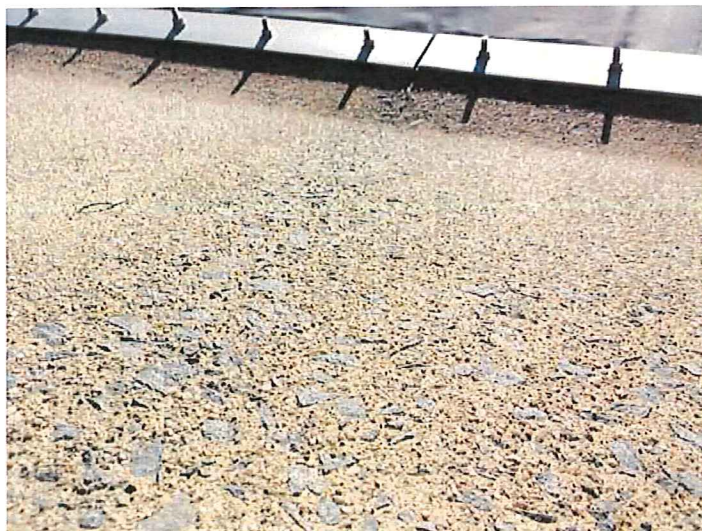
12) Same.

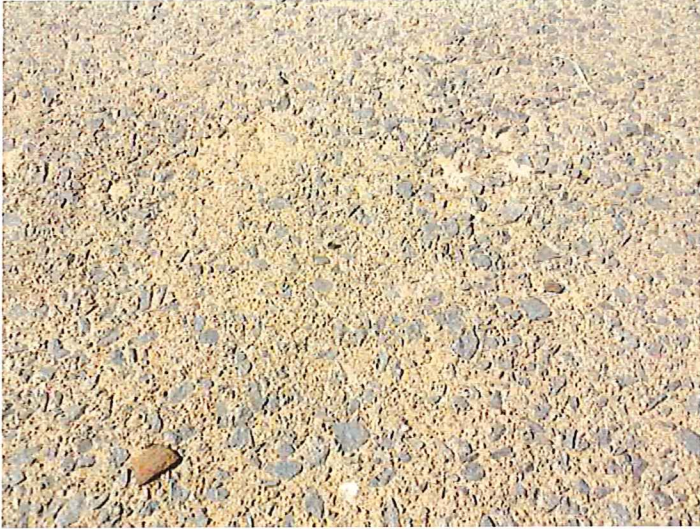
The floor is poured in-place concrete with cold joints. There are no signs of cracking or spalling. The catwalk platforms are supported by concrete columns that are in good condition with no significant cracking or spalling.

13) Concrete floor slab is in good condition.

The interior floor has not deteriorated to the point of needing repairs.

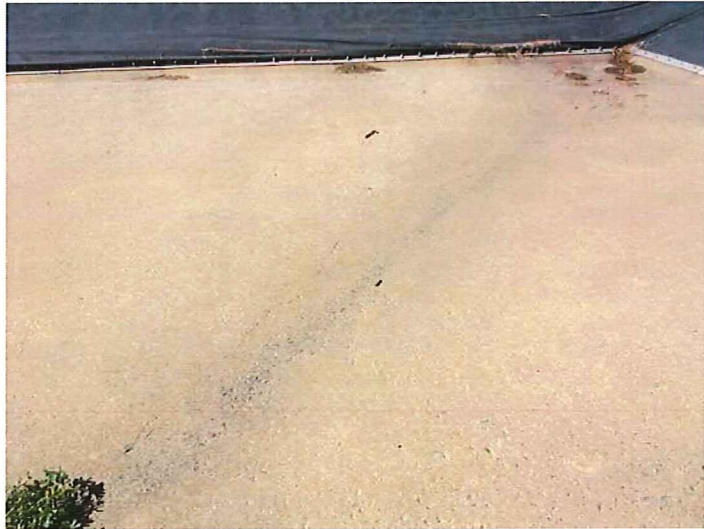
14) Same.

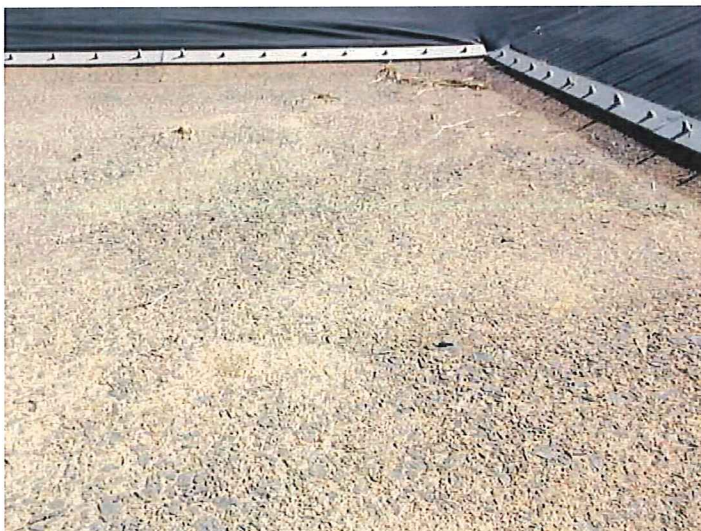
15) Same.

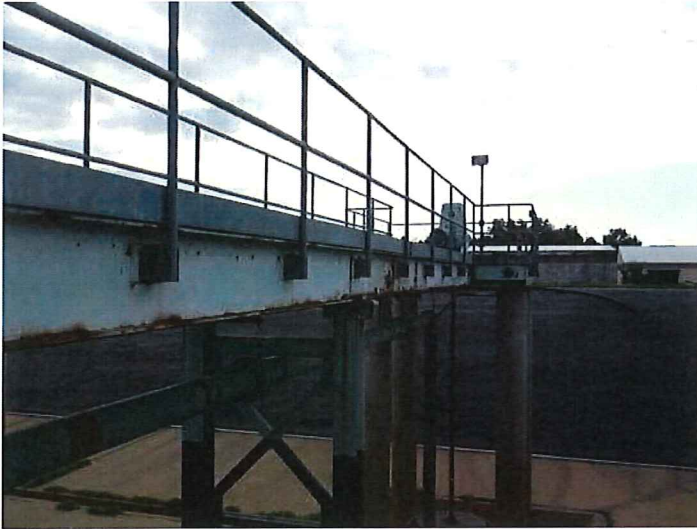
Two catwalks run from the edge of the basin to the center and are constructed of steel beams and supports. The catwalks are in good condition but the coating is in poor condition with extensive surface corrosion on the support steel.

The coating was tested at 1.6 percent (16,000 ppm) lead by weight, 0.28 percent (2,800 ppm) chromium by weight. Special considerations will be needed during maintenance to avoid contamination of workers, and prevent generation of a hazardous waste.

16) The catwalk structural steel and piping coating is in poor condition.

Abrasive blast clean to a commercial grade (SSPC-SP6) the steel catwalk beams, support structure, and piping. Apply an epoxy urethane system to steel surfaces above high water line and zinc epoxy system to steel surfaces below the high water line. The estimated cost is \$50,000.

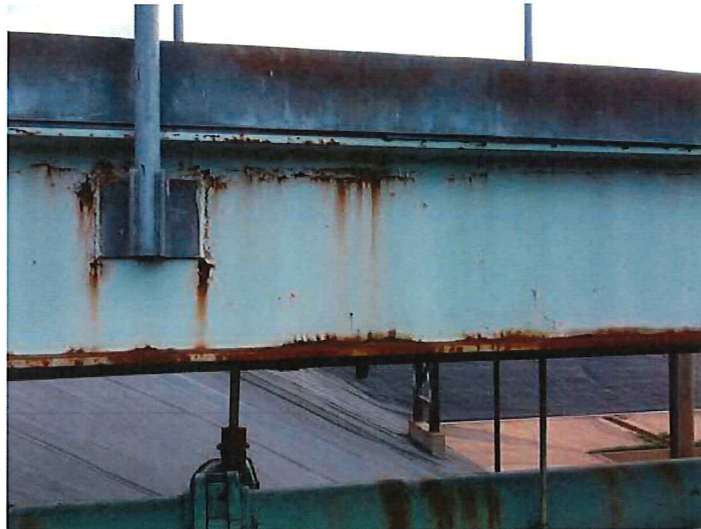
17) Same.

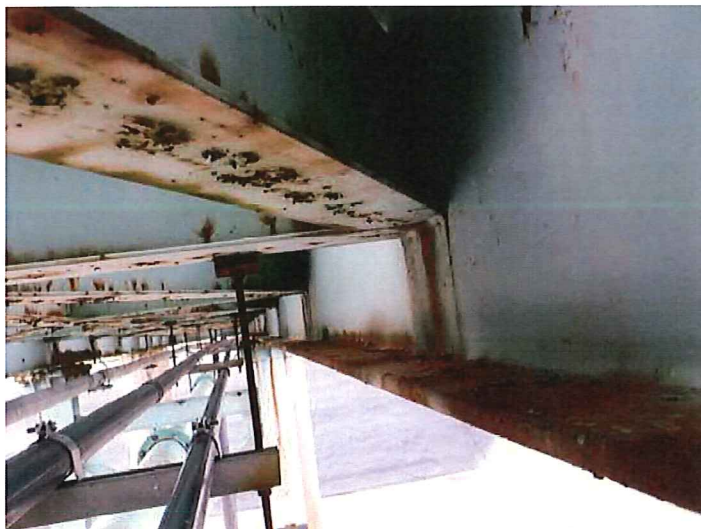
18) Same.

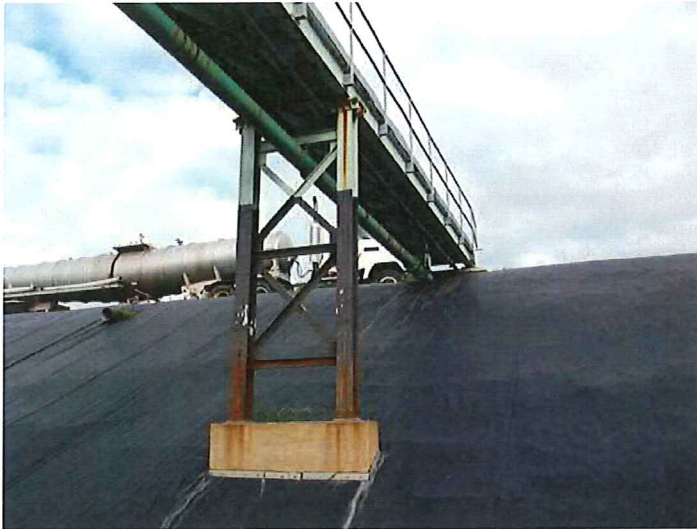
19) Catwalk supports have general surface rusting.

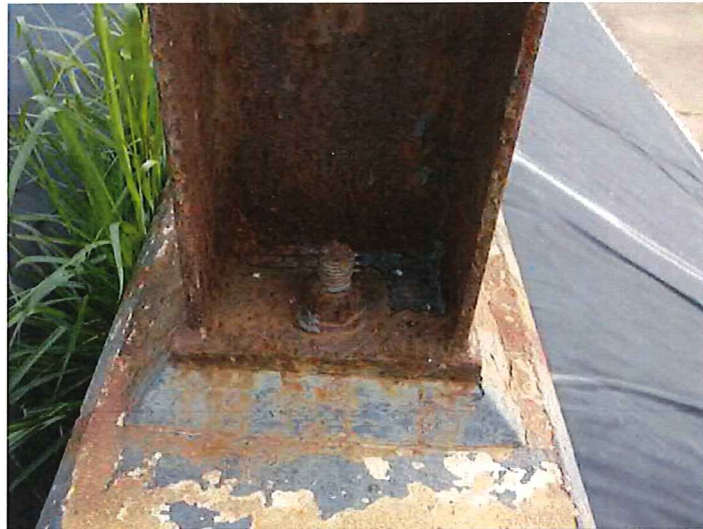
20) Same.

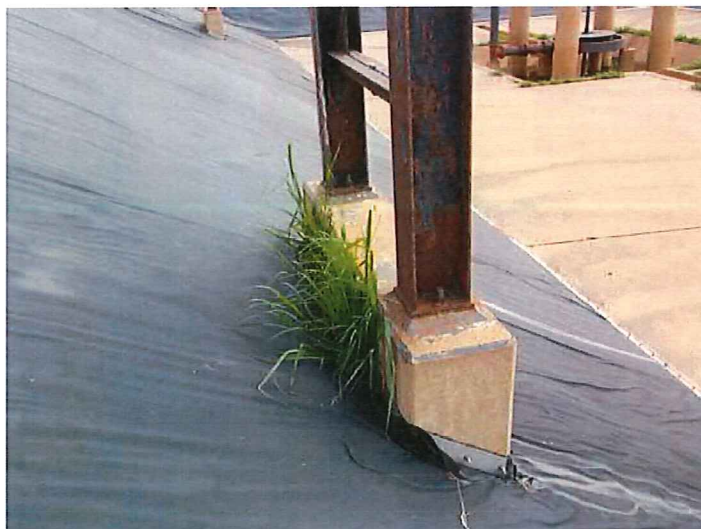
21) Same.
