Re: 1,250,000 Gallon Equalization Basin A Storage Tank
Preliminary Maintenance Inspection

Preliminary Maintenance Inspection

1,250,000 Equalization Basin A

Leesburg, Virginia

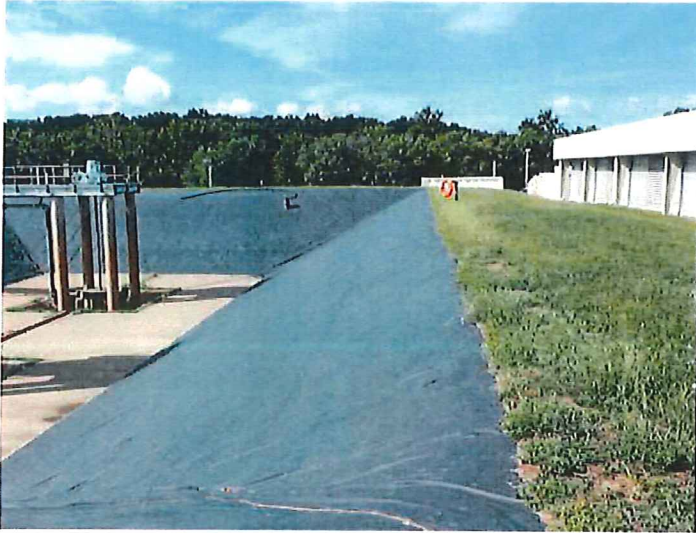
The interior has a rubber liner that covers the sidewalls and is in fair condition with numerous rips and other damage. The bottom edge of the liner is secured with aluminum strips and bolted into the concrete. There are a few of the bolts that are missing. The vertical seams of the liner have been heated and sealed together. The top edge of the liner has been buried. The liner is loose and sagging in many areas.

1) Rubber liner on dirt sloped walls.

Install a new 45 mil thick rubber liner on the interior sloped dirt walls. Secure edges of the liner at the concrete floor with aluminum strips and anchor bolts. Liner seams on the slope should be heated and fused together with liquid sealant. Liner edges at the top of the walls should be buried. The estimated cost is \$50,000.

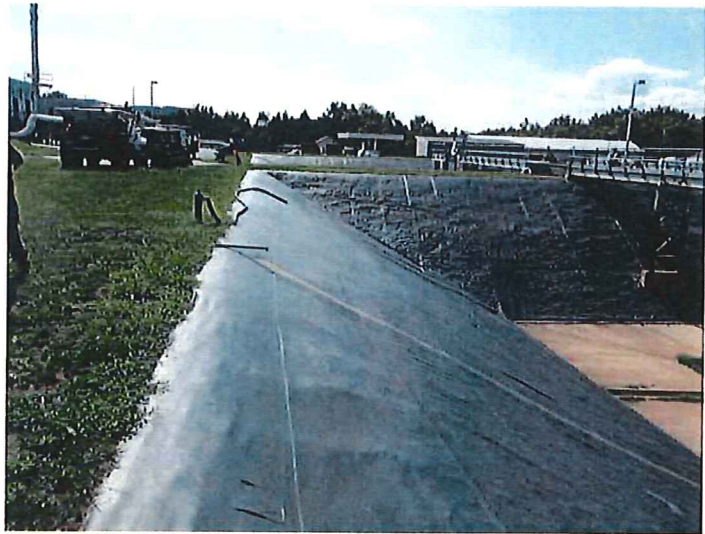
2) Same.

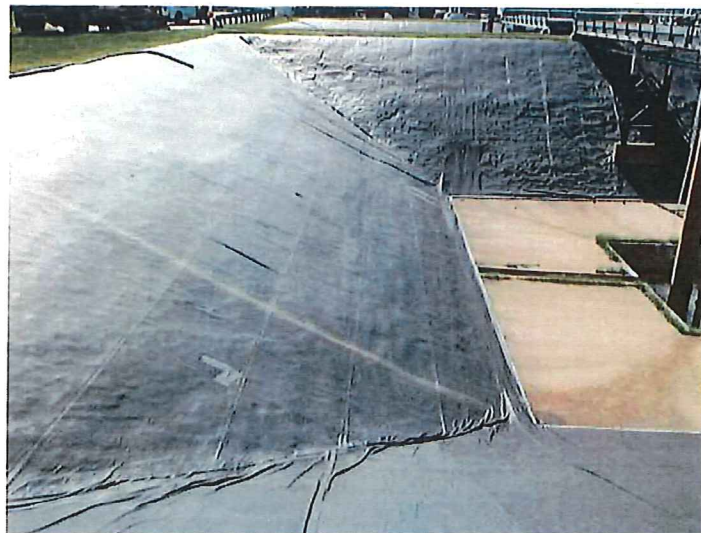
3) Same.

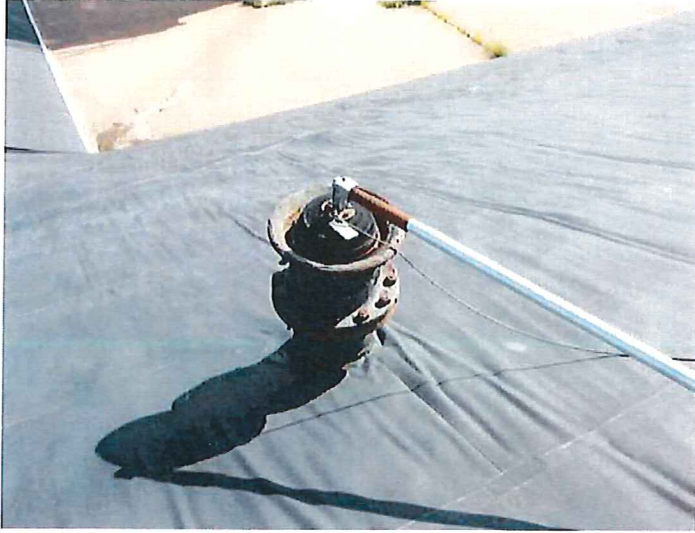
4) Pipe penetrations in wall liner.

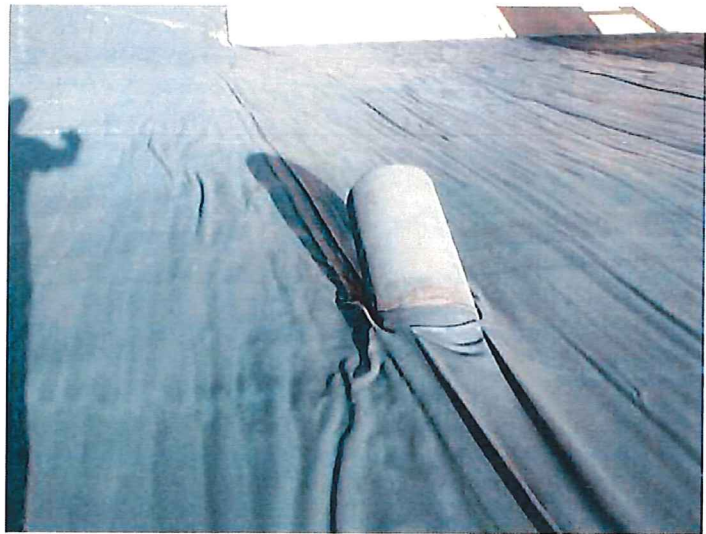
5) Same.

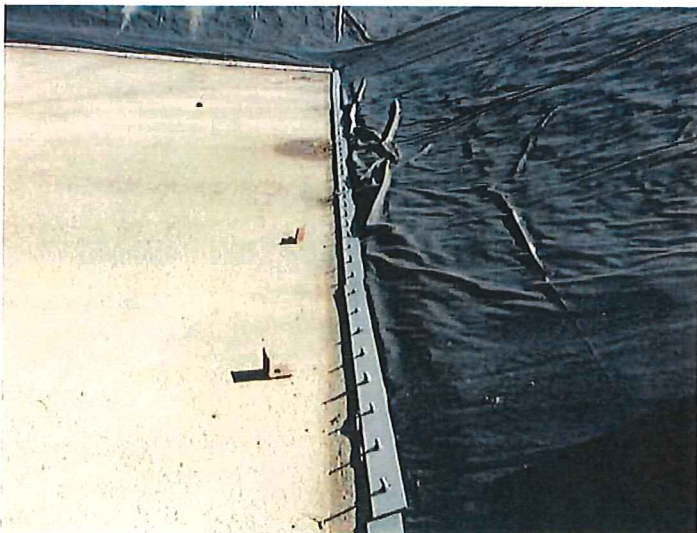
6) Liner secured with aluminum strips and bolts at concrete floor.

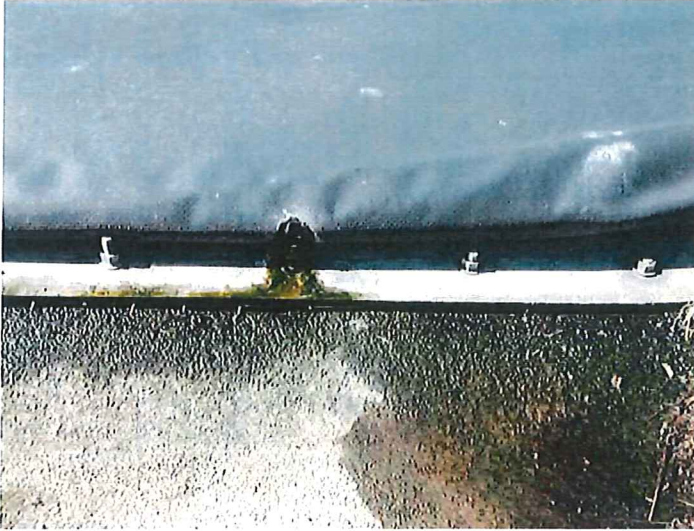
Wall to floor junction comments: **Two bolts missing**

7) Liner is tearing at bolted strips.

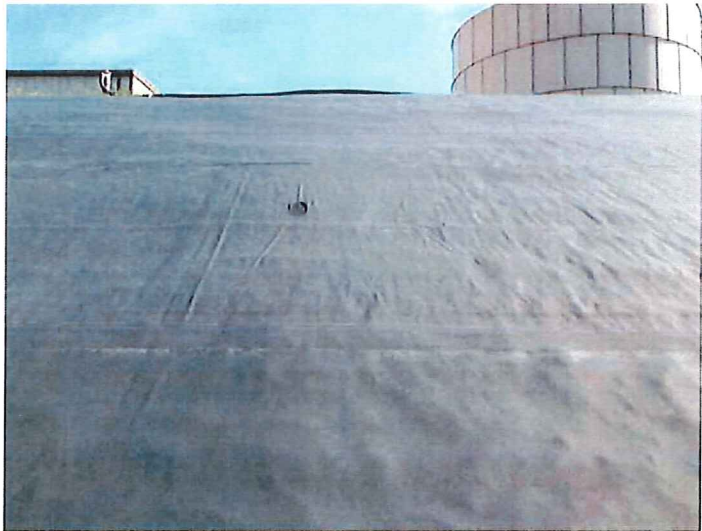
8) Random holes found in liner.

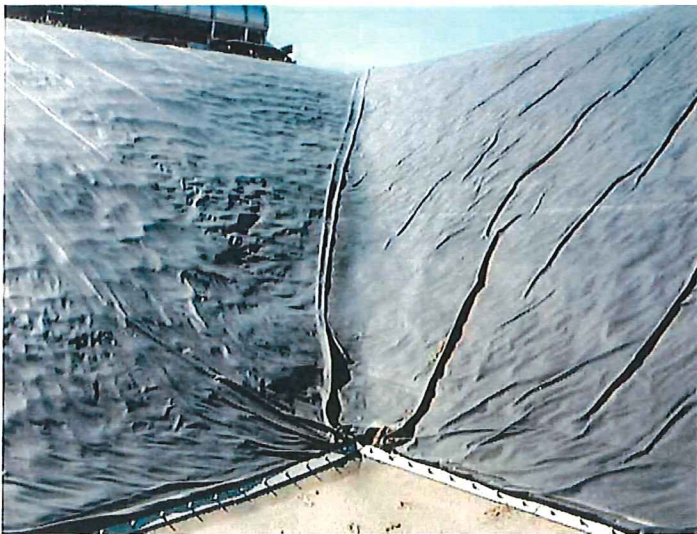
9) Liner is loose and sagging in many areas.

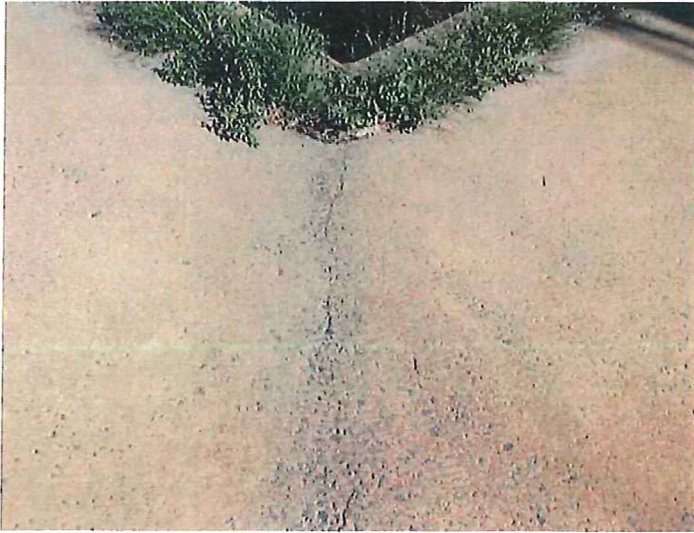
The floor is poured in-place concrete with cold joints. There are no signs of cracking or spalling. The catwalk platforms are supported by concrete columns that are in good condition with no significant cracking or spalling.

10) The concrete floor is in good condition.

The interior floor has not deteriorated to the point of needing repairs.

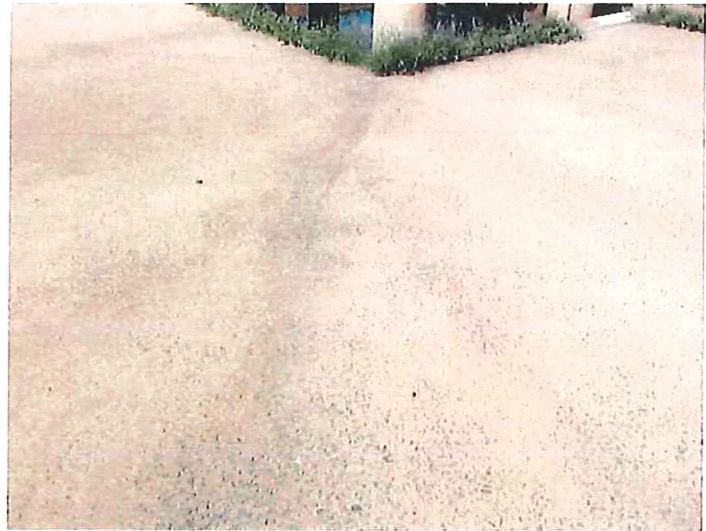
11) Same.

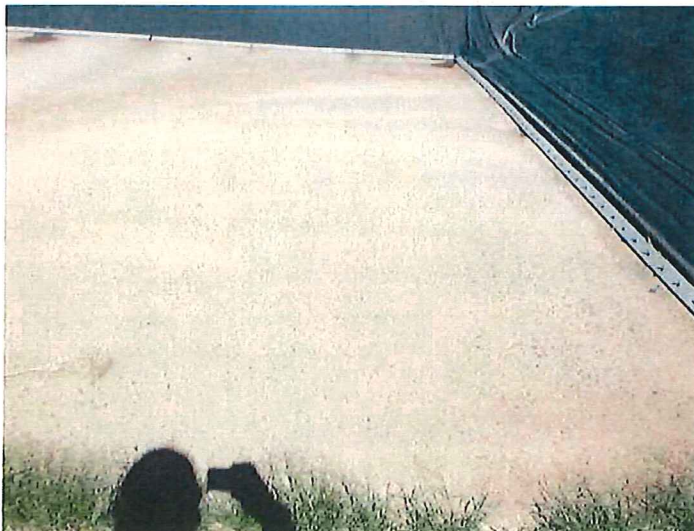
12) Same.

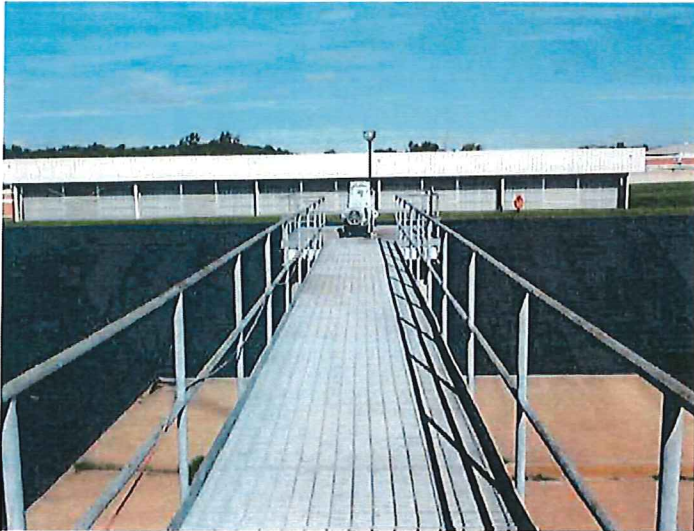
13) Catwalk starts at top edge of basin and extends to center of tank.

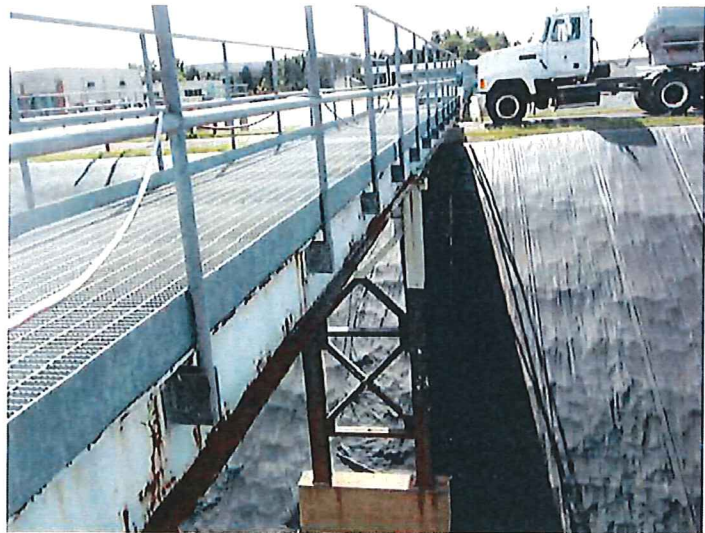
Two catwalks run from the edge of the basin to the center and are constructed of steel beams and supports. The catwalks are in good condition but the coating is in poor condition with extensive scale corrosion on the support steel.

The coating was tested at 0.57 percent (5700 ppm) lead by weight, 0.47 percent (4700 ppm) chromium by weight. Special considerations will be needed during maintenance to avoid contamination of workers, and prevent generation of a hazardous waste.

14) The coating on the catwalk is in poor condition.

Abrasive blast clean to a commercial grade (SSPC-SP6) the catwalks, support structures, and piping. Apply an epoxy urethane system to steel surfaces above high water line and zinc epoxy system to steel surfaces below the high water line. The estimated cost is \$50,000.

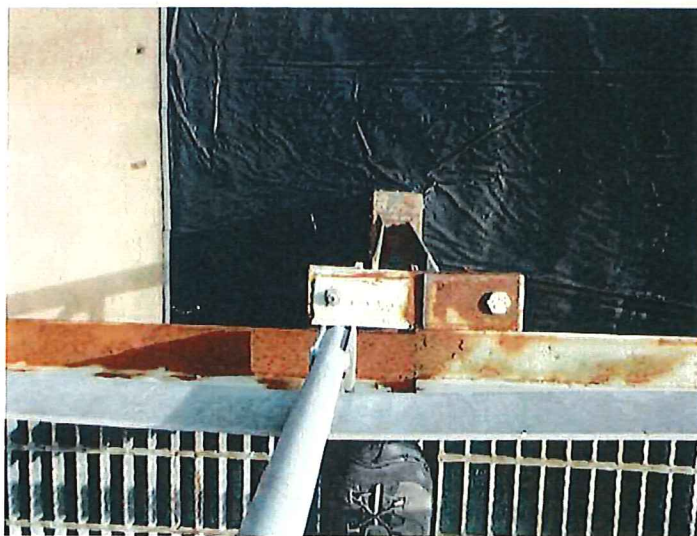
15) Same.

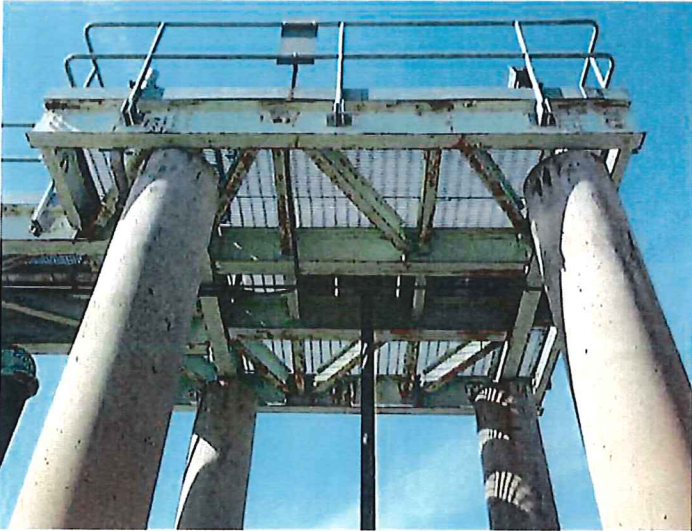
16) Same.

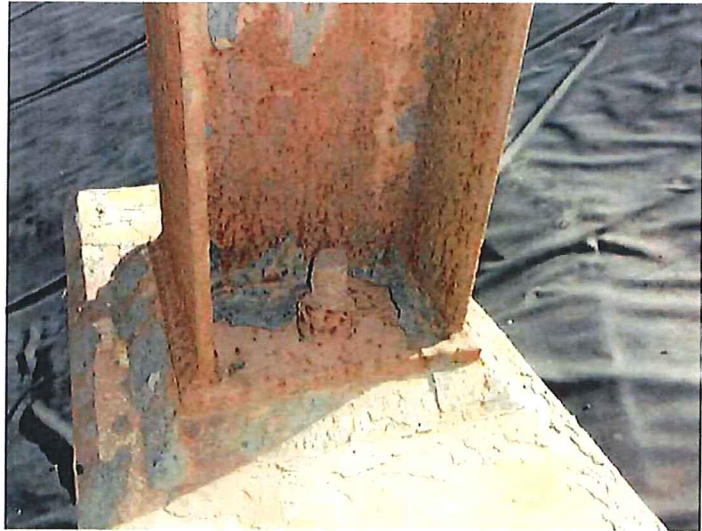
17) Catwalk supports have general surface rusting.

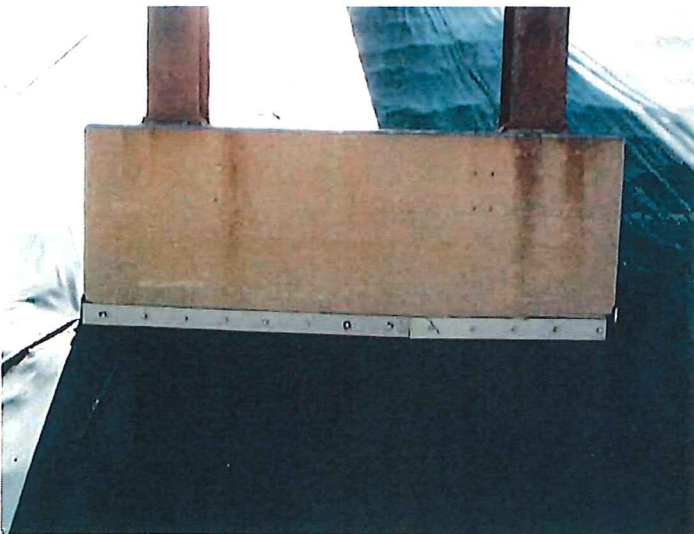
18) Same.

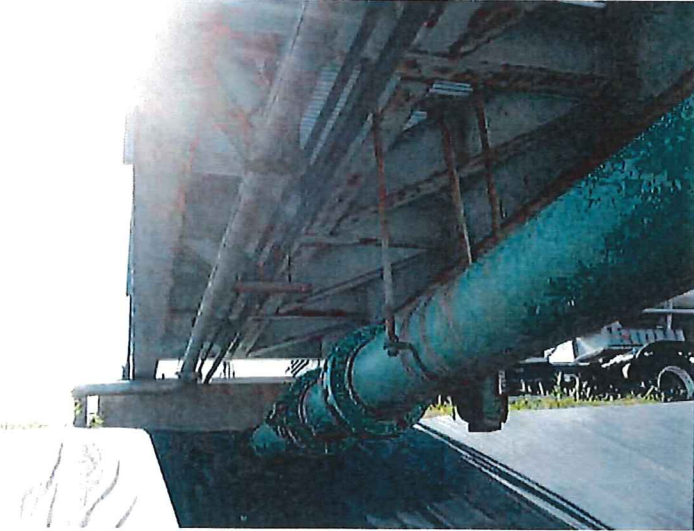
The piping in the interior runs along the catwalks to the center of the basin and extends down to the floor. The piping is in good condition but the coating is in fair condition. The pipes have general surface rust and delamination.

Location: Adjacent to tank
Condition of pipe coating: Poor
Describe coating: Delaminating, spot coating failures to substrate, rust bleedthrough, and rust undercutting
Condition of metal: Good
Piping comments: Piping is above basin along catwalk to center of basin

19) Piping is attached to underside of catwalk. Coating is in fair condition with rusting at fittings.

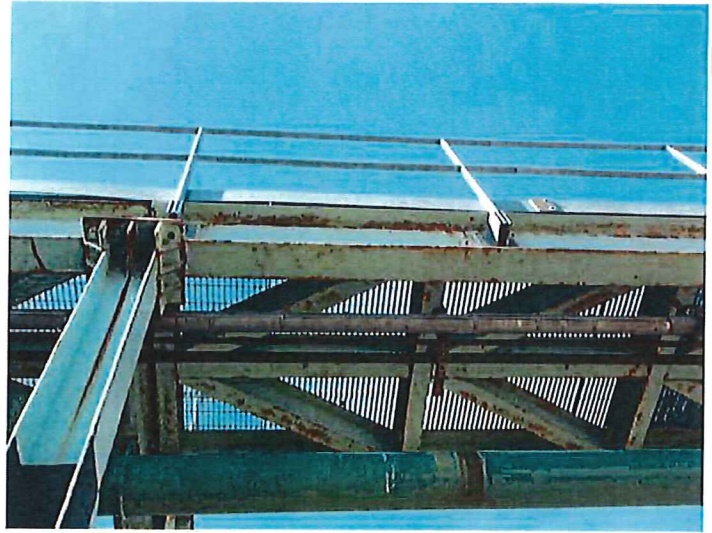
20) Same.

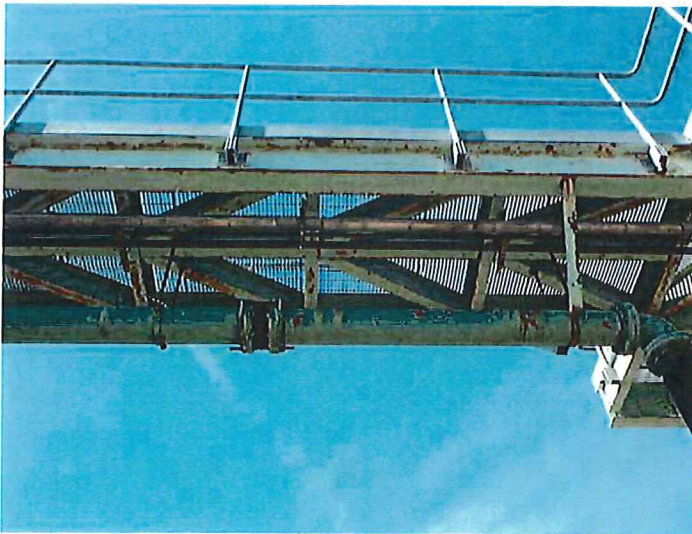
21) Same.
