Re: 315,000 Steel Reservoir Storage Tank
Preliminary Maintenance Inspection

Preliminary Maintenance Inspection

315,000 Gallon Bolted Reservoir

Leesburg, Virginia

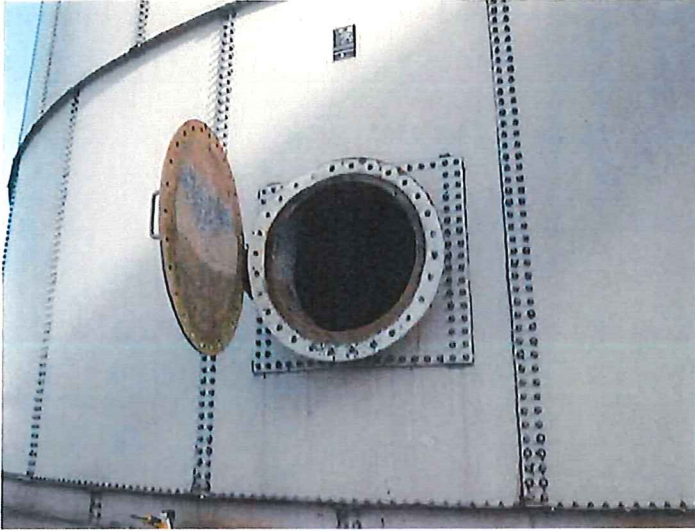
The tank has a 24 inch diameter bolted manway in the sidewall that is in good condition.

1) Sidewall manway is in good condition.

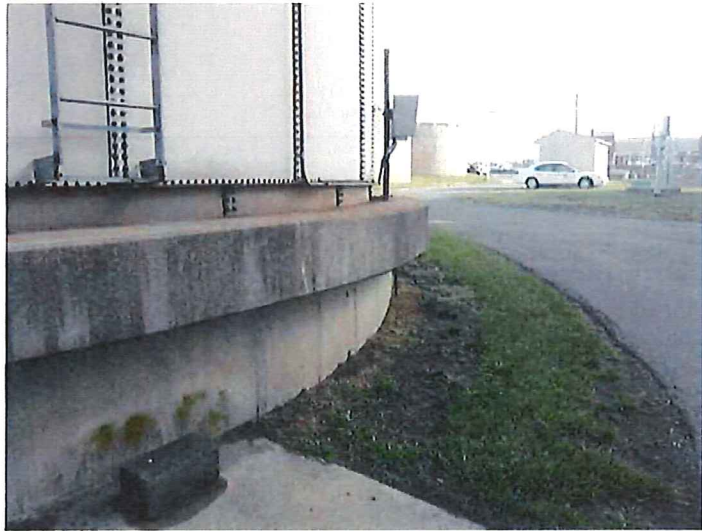
Forty-six inches of the foundation is exposed with a 16 inch curb. The exposed foundation is in good condition with some tight cracking, but is not coated.

2) Foundation is in good condition with a few cracks.

Repair the cracks in the foundation by routing and filling with a mortar repair system. The estimated cost is \$2,000.

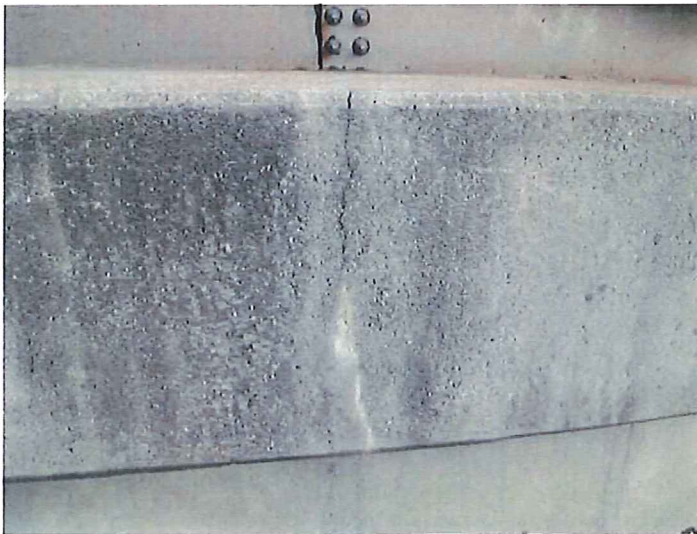
3) Vertical cracking is tight.

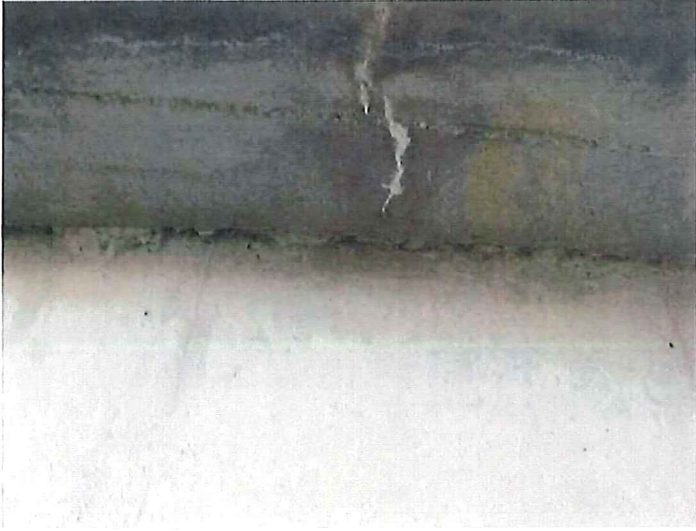
4) Cracking on underside of foundation.

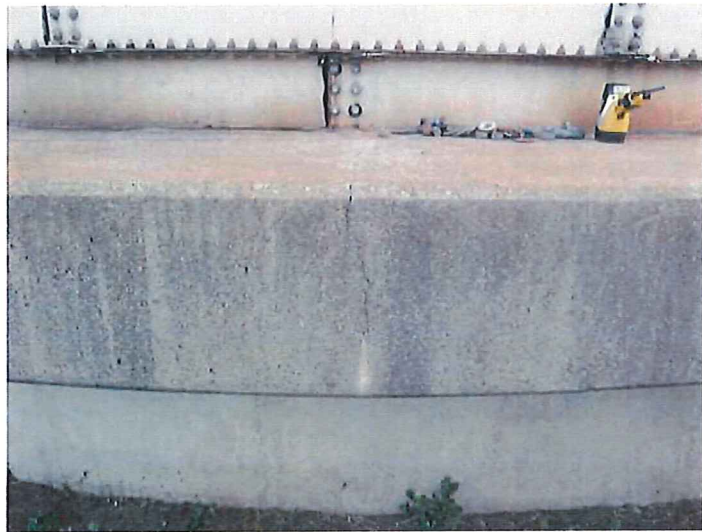
5) Another area of vertical cracking.

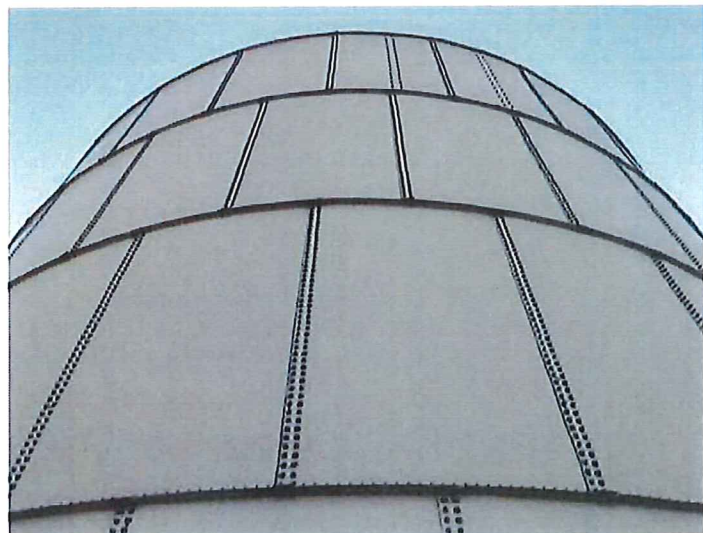
The coating system is an acrylic urethane system. The coating is in fair condition overall, it is beginning to chalk and fade and there is loss of gloss. Surfaces have faded due to exposure to ultraviolet light, which is a normal occurrence for an exterior coating system. There are several coating failures.

6) Exterior coating is faded with spot failures.

Remove the existing coating by dry abrasive blast cleaning the steel to a commercial (SSPC-SP6) condition and apply a polyurethane system. All blast work would be performed inside a dust tight flexible containment system using negative air pressure.

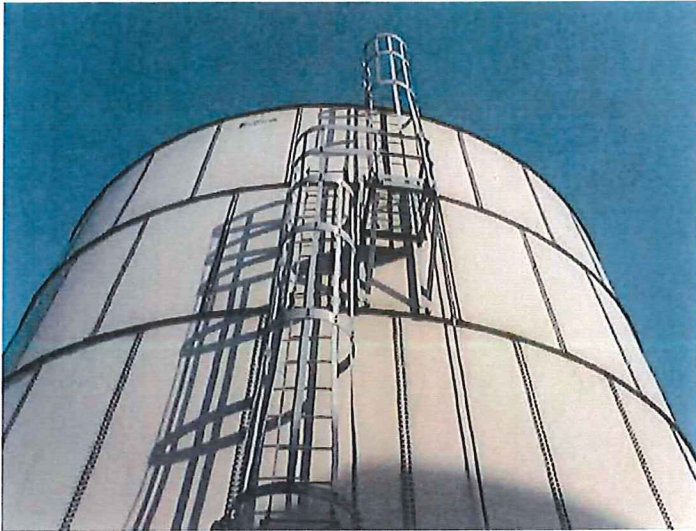
The tank has an exterior sidewall ladder that starts approximately four feet above ground level, and extends up to a small platform halfway up the sidewall. There is a second ladder on the other side of the platform that extends to the roof. The ladder is caged but there is no fall prevention device.

7) Caged sidewall ladder equipped with a cable fall prevention device.

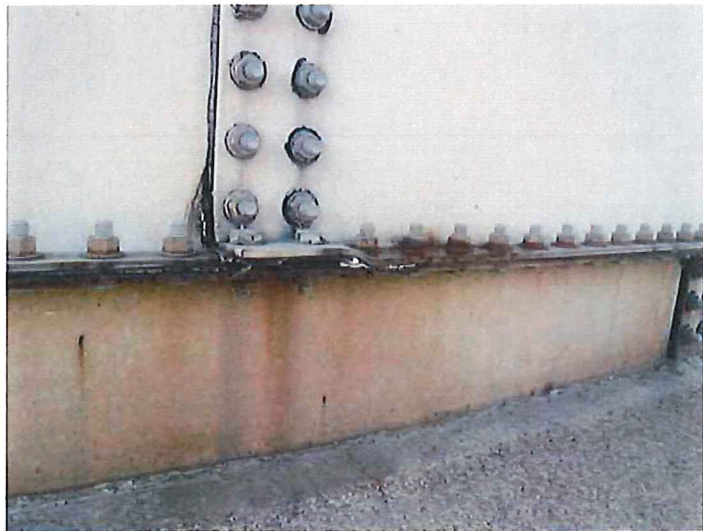
The sidewall coating is in fair condition with only a few failures. Primary method of deterioration is spot coating failures to the substrate. The gasket at the sidewall bolted connection is in fair condition with cracking. There is some rust streaking coming from the bolted connection.

8) Coating failures on the bottom section of the sidewall.

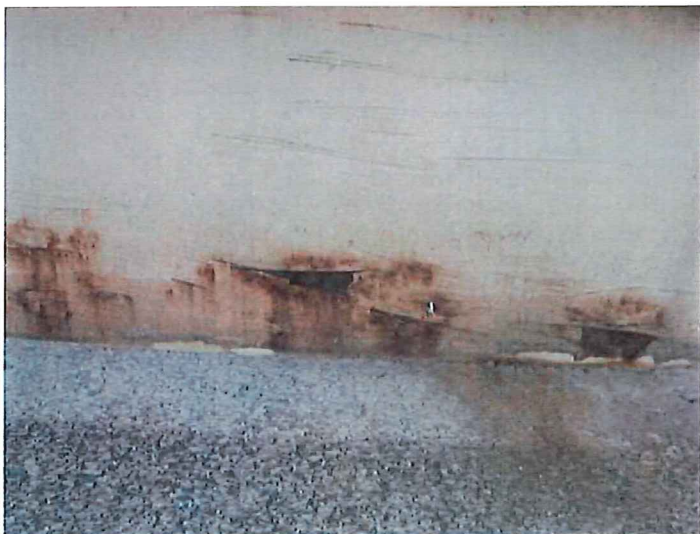
9) Sidewall coating failures above foundation.

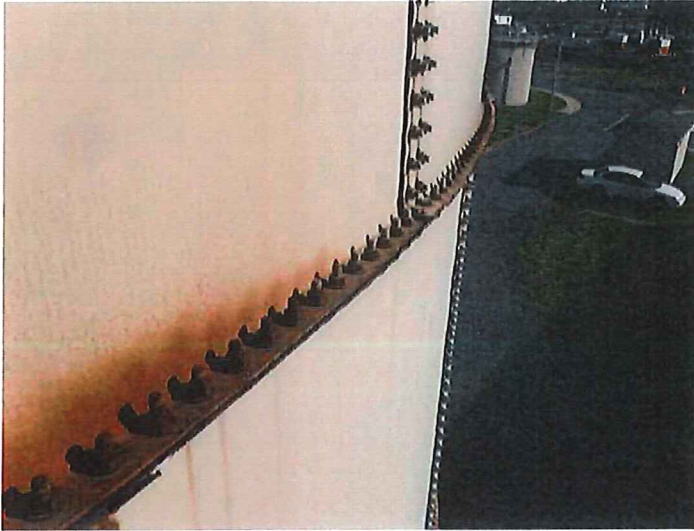
10) Rusting on lip of bolted side-wall stiffener.

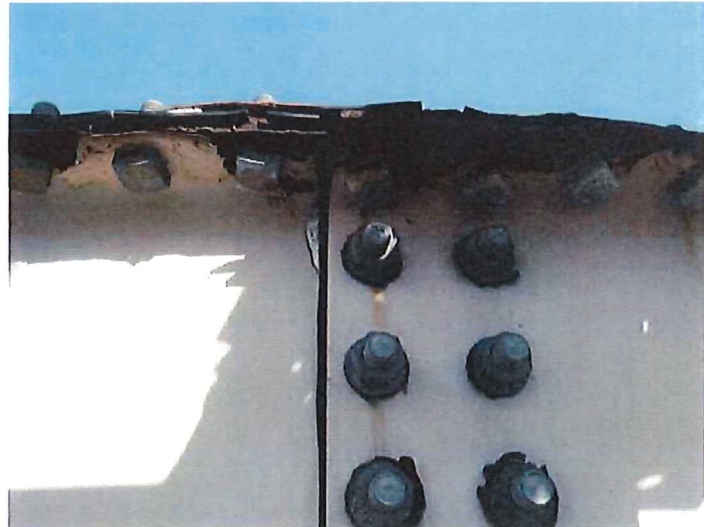
11) Top of sidewall at lip with coating failures and rusting.

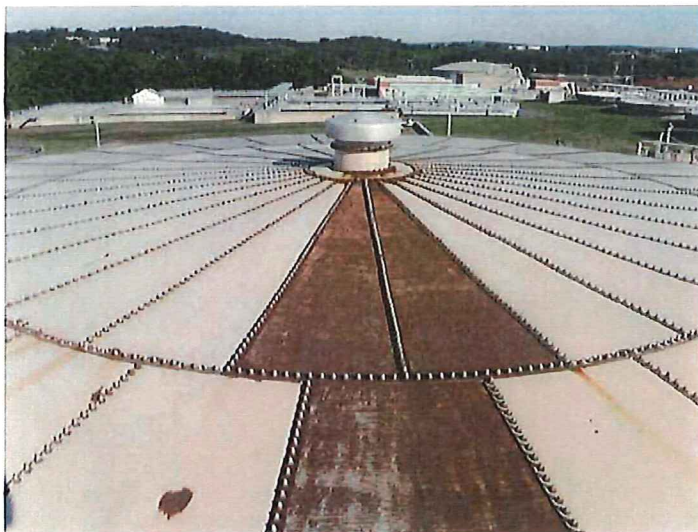
The roof coating is in poor condition with numerous failures. There is complete coating failure on several roof panels likely from poor shop painting. Primary methods of deterioration are spot coating failures to the substrate and surface rusting. The gasket at the roof bolted connection is in fair condition with cracking. There is some rust streaking coming from the bolted connection.

12) Roof panels with surface rusting.

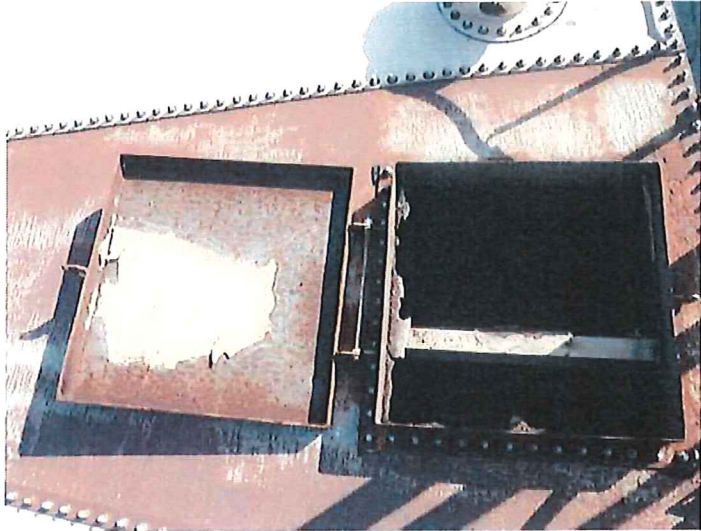
13) Roof cover with coating failures and surface rusting.

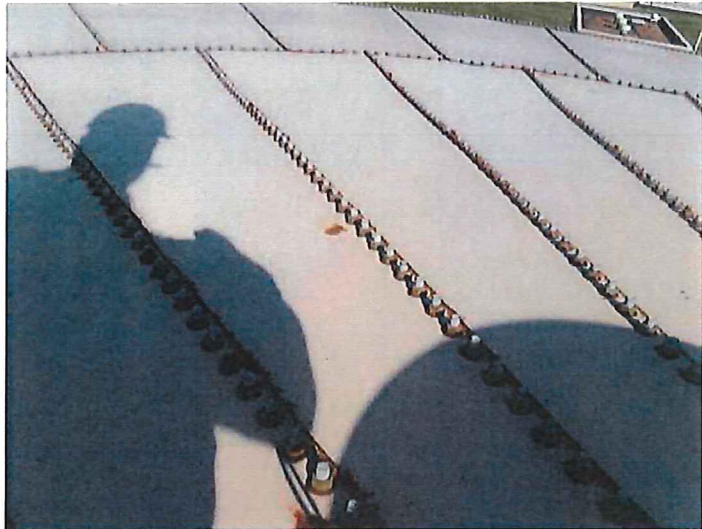
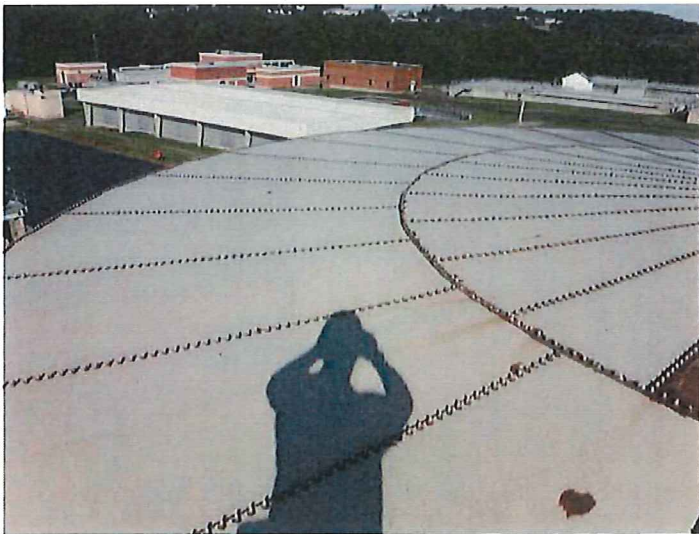
14) Spot coating failures on the roof.

15) Same.

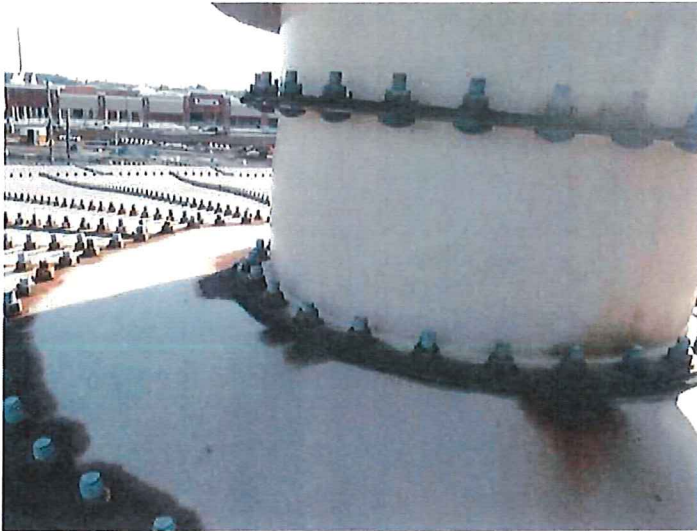
The roof vent is a 20 inch flow through design that is in fair condition. The screen is fully intact.

16) Roof vent with rusting bolted connections.

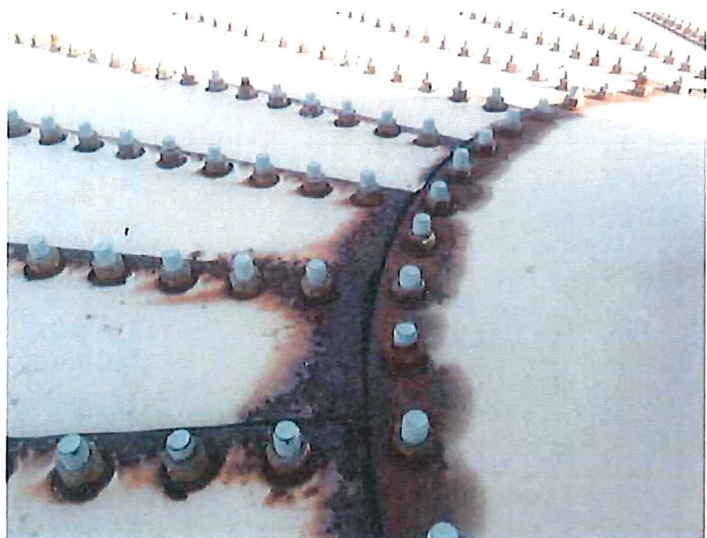
17) Rusting bolted connections at the center of the roof.

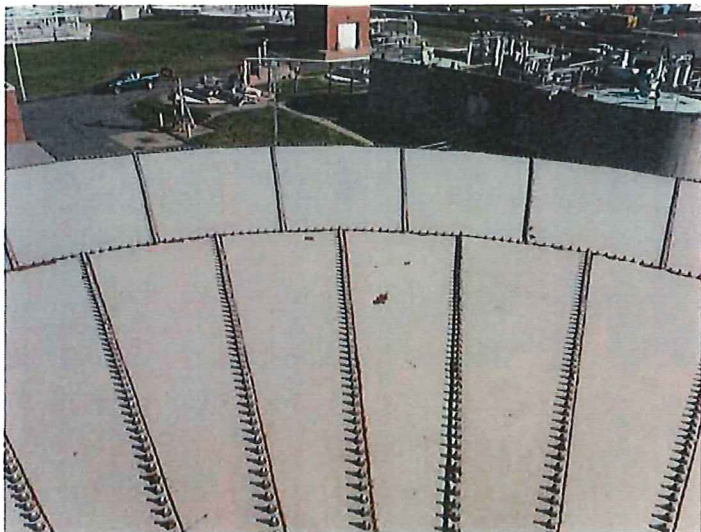
18) Roof coating is faded and in fair condition.

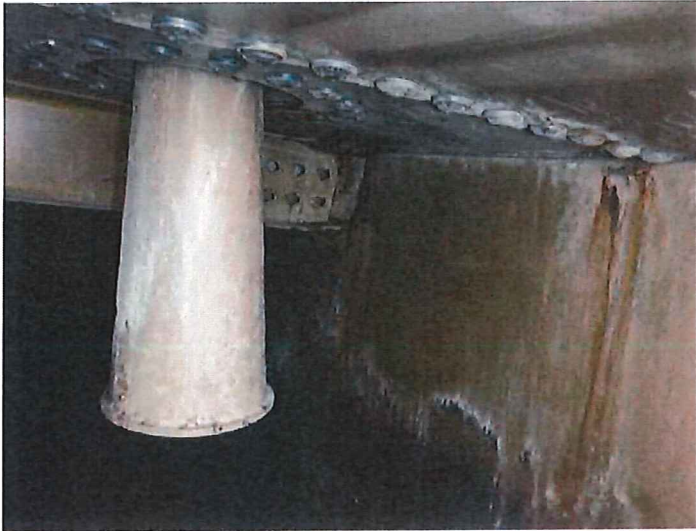
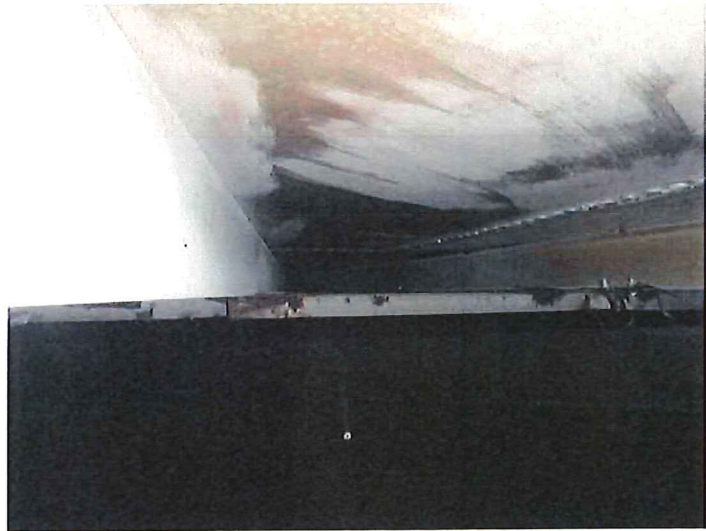
The sidewall coating is in fair condition with several failures. Primary method of deterioration is spot coating failures from age and crevice corrosion at bolt edges.

19) Spot coating failures at top of the interior sidewall.

20) Same.

Remove the coating system by abrasive blast cleaning the metal to a near-white metal (SSPC-SP10) condition and apply an epoxy coating system. The estimated cost to apply the three-coat epoxy system is \$100,000. This cost includes caulking all the interior panel seams, bolts, and nuts.

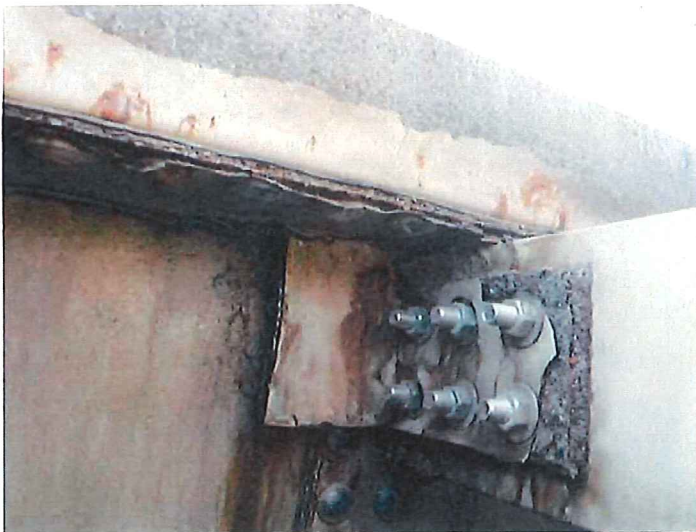
The connections at the sidewall are bolted and in poor condition. The connections at the I-beam supports are bolted and in poor condition. The connection at the center support is bolted and in poor condition. The bolted stiffener connection plates have almost no coating remaining and there is corrosion with steel loss.

21) Roof stiffeners bolted to sidewall connection plates with coating loss and corrosion forming.

Weld the roof stiffener connections at the sidewall. The estimated cost is \$15,000.

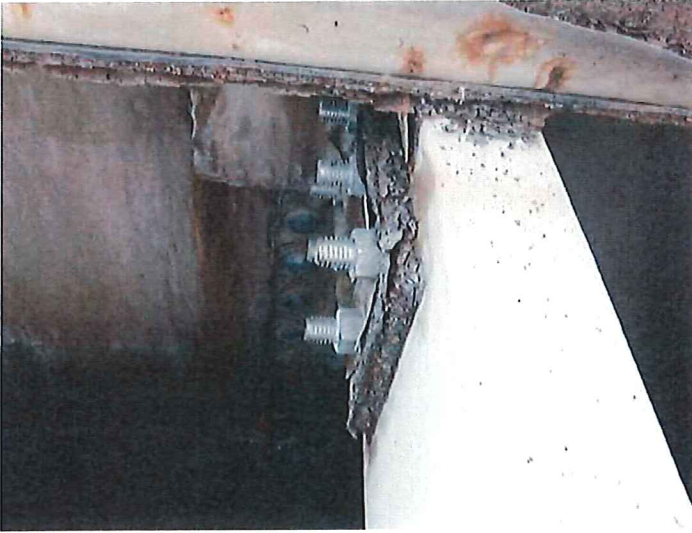
22) Roof stiffener plate with steel loss.

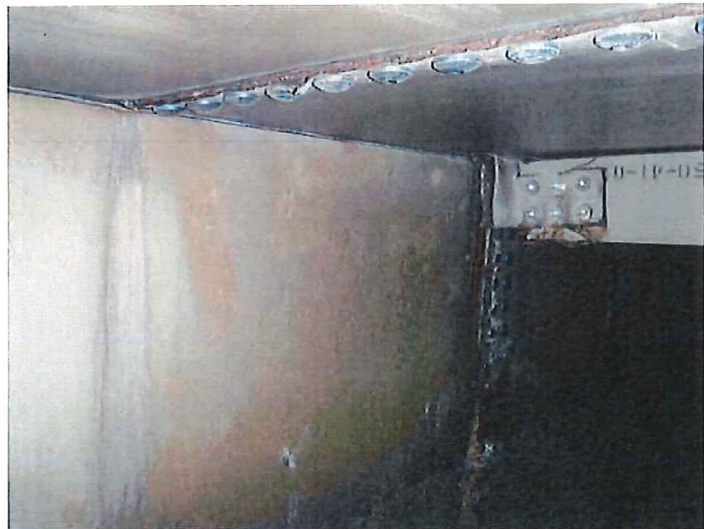
23) Rusting at roof bolted connection.

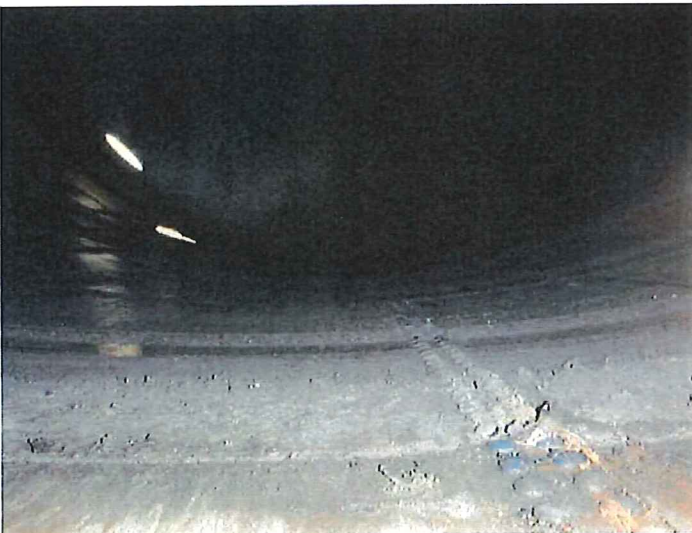
24) Sidewall with rusting at bolted connection.

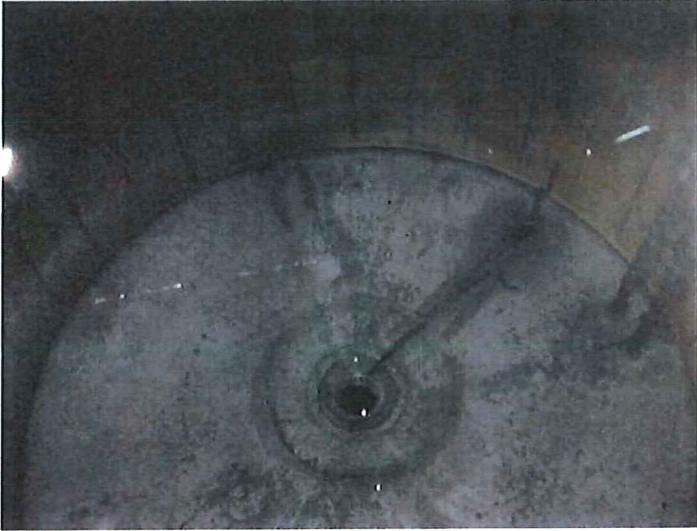
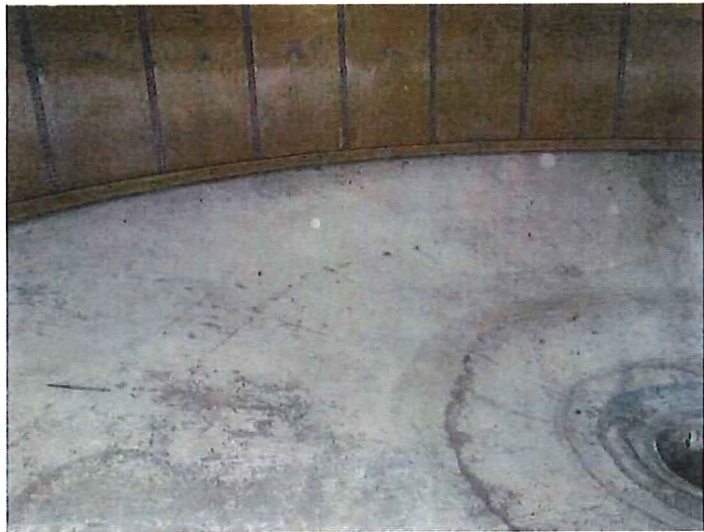
25) Concrete floor is in good condition.

26) Same.

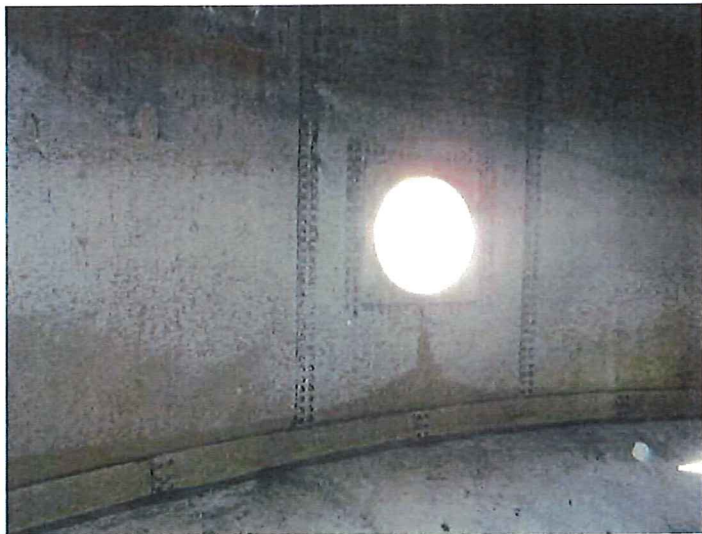
27) Sidewall manway viewed from interior.

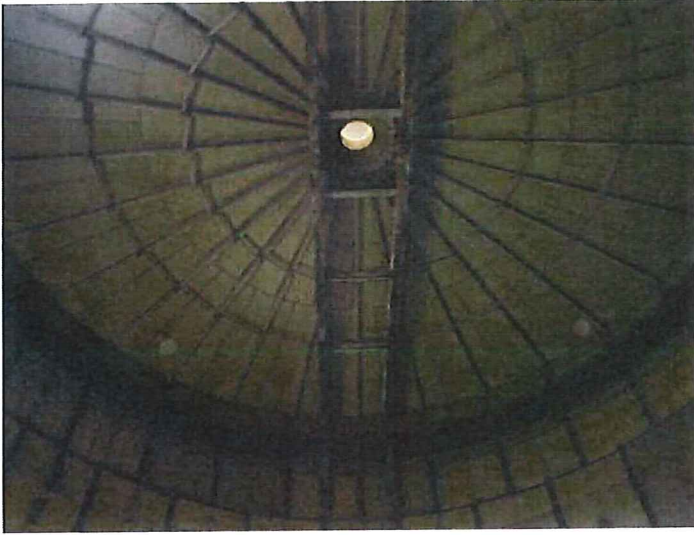
The interior roof is supported by 28 radial stiffeners that are in fair condition with moderate corrosion in the crevices and at the edges. There are two circular stiffener rings, and two large transverse I-beam supports.

28) Bolted steel roof with radial stiffeners.

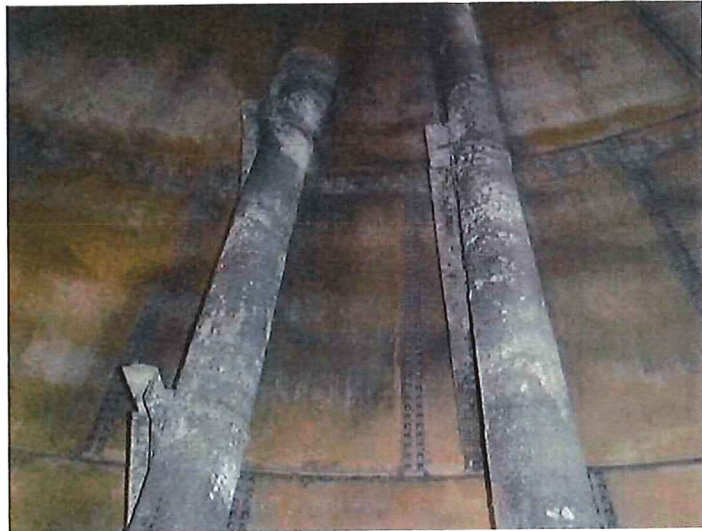
29) Interior piping is in fair condition.

Abrasive blast clean the piping to a commercial blast (SSPC-SP6) condition and apply an epoxy system. The estimated cost is \$10,000.

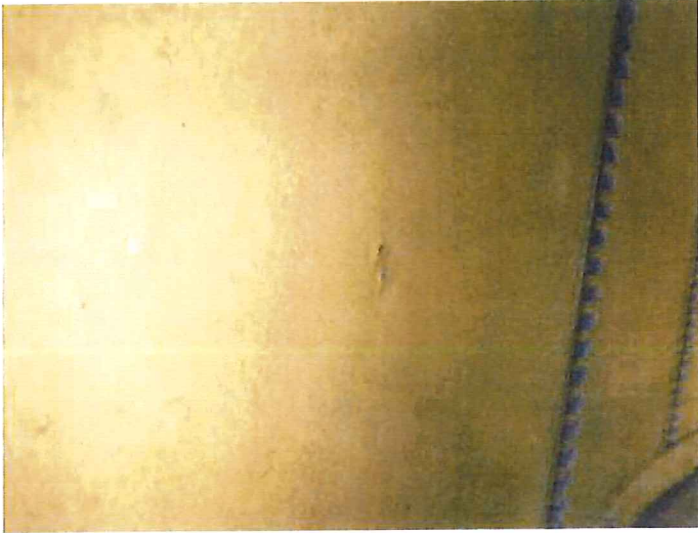
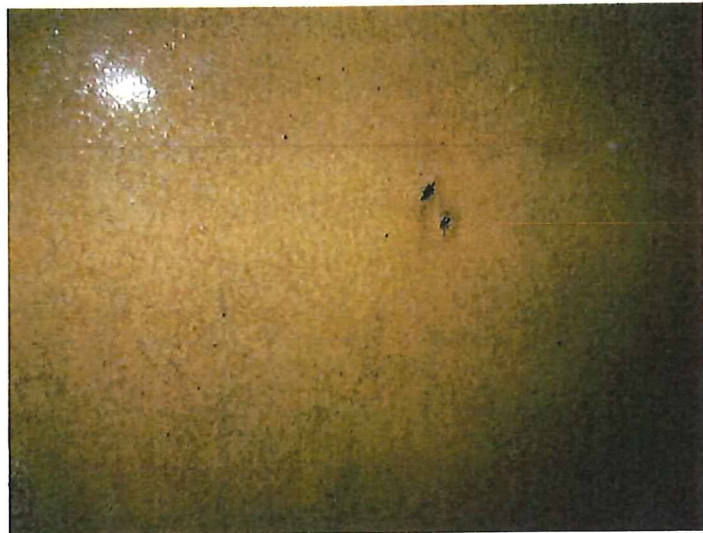
31) Spot coating failures on the sidewall.

32) Same.

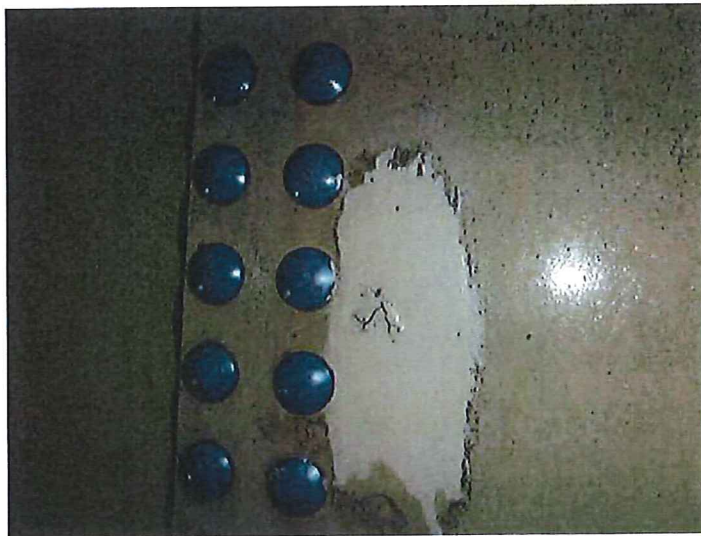
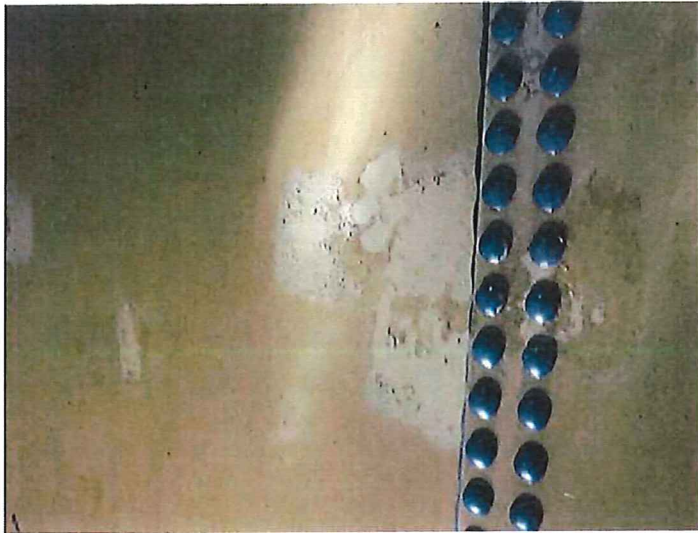
33) Coating repair made on the sidewall.

34) Same.

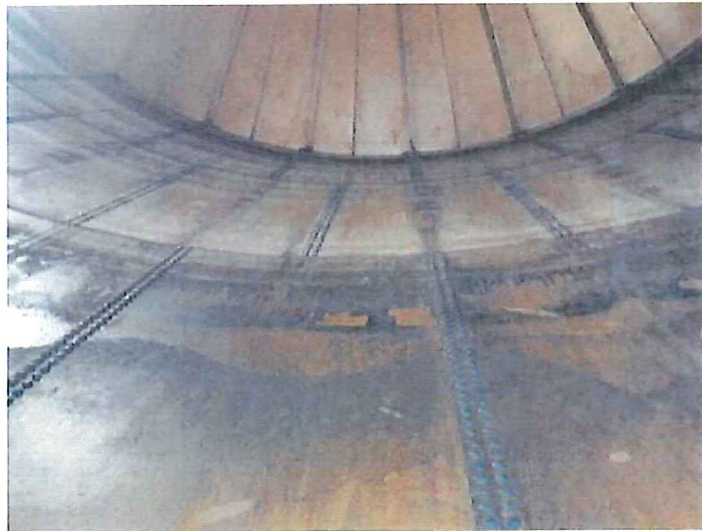
35) Sidewall coating is in fair condition.

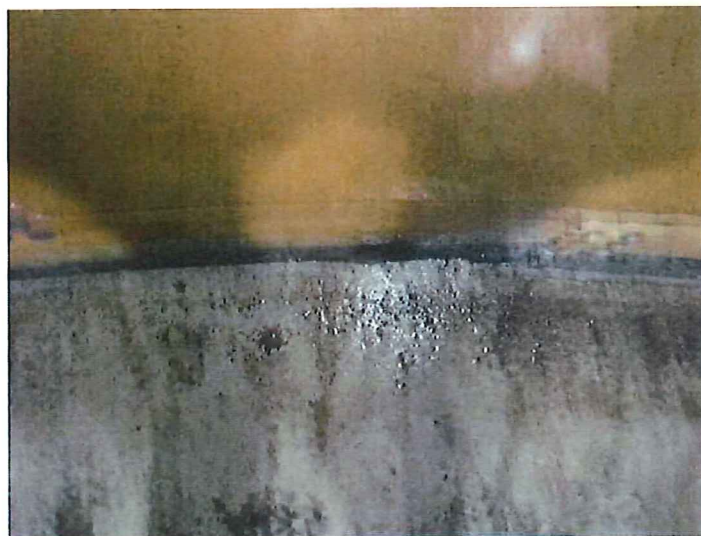
36) Floor to sidewall connection is in good condition.
