Dixon Engineering, Inc.

Preliminary Maintenance Inspection

Wastewater Treatment Plant
Digester B

Leesburg, Virginia

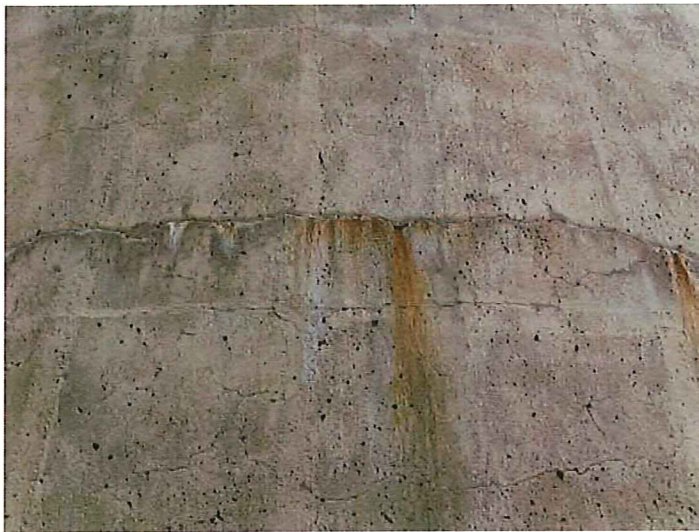
Approximately 14 feet of the exterior walls are exposed and are poured in-place. The sidewalls are in fair condition. There are several tight cracks with edges in place. The cracks are horizontal with efflorescence and rust staining present.

1) Horizontal cracking on the sidewall.

Clean out cracks by routing the crack to a u-shape and fill with a mortar repair system. The estimated cost is \$3,000.

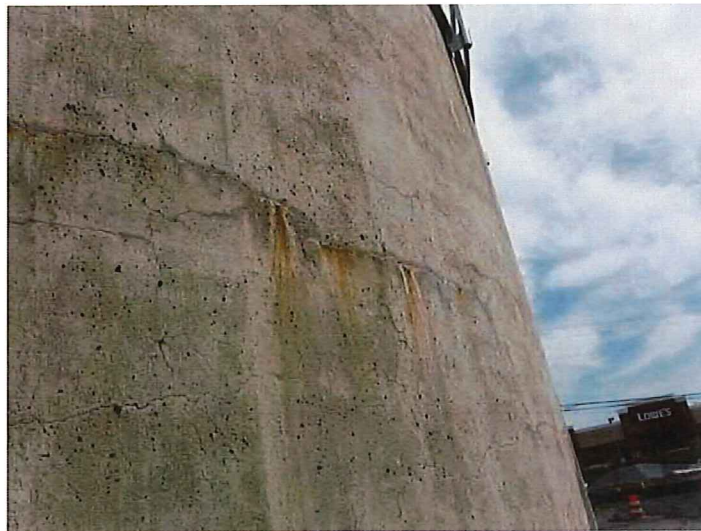
2) Same.

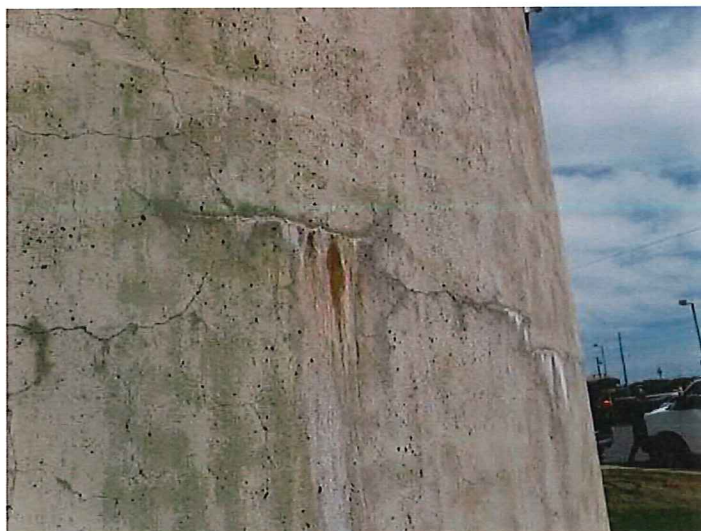
3) Same.

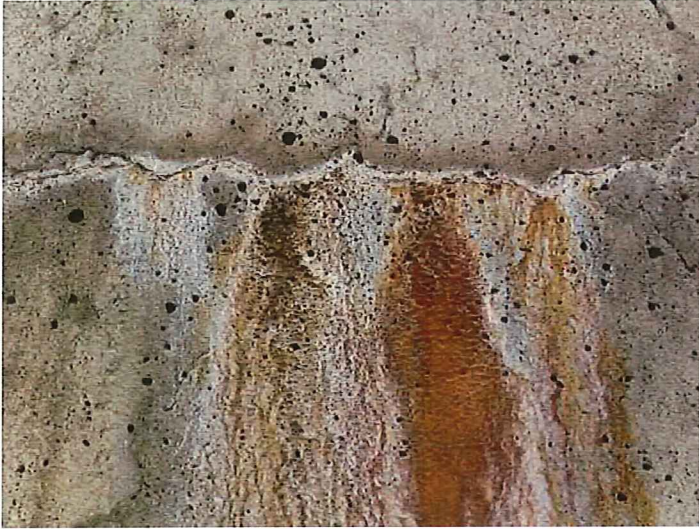
4) Efflorescence and rust staining at cracking.

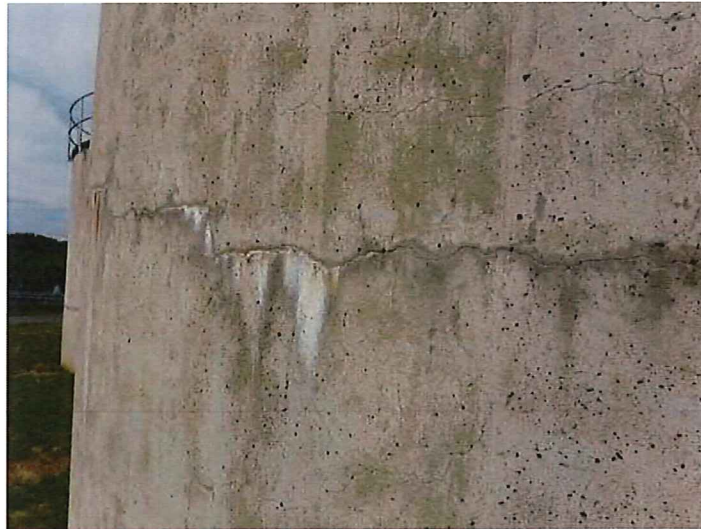
5) Same.

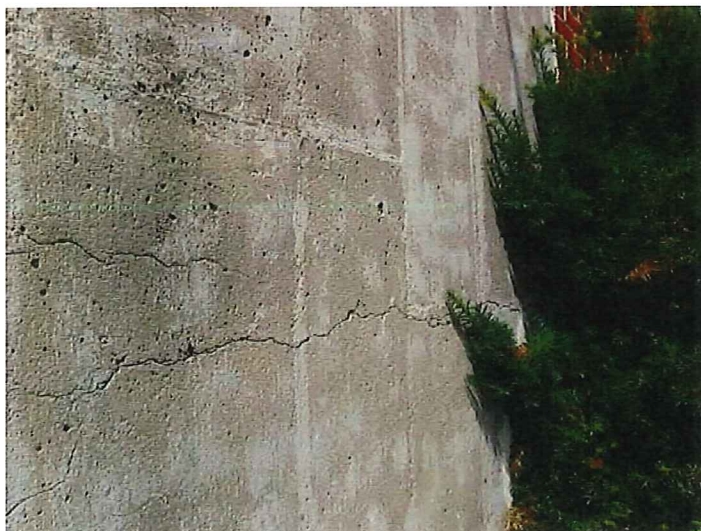
6) Cracking is tight.

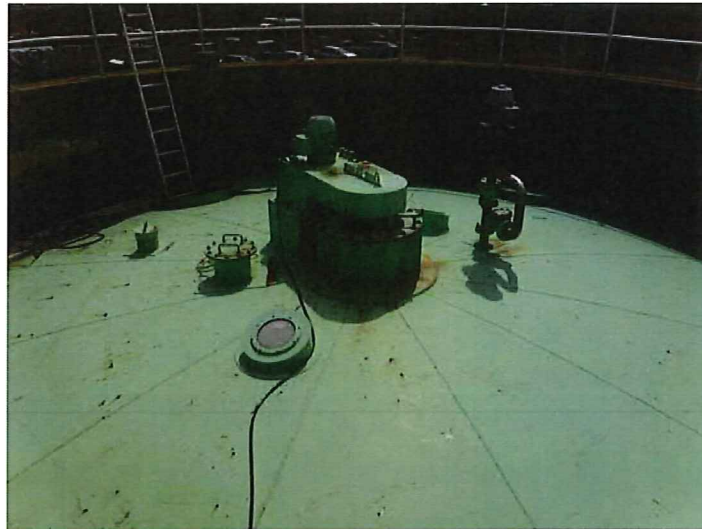
The exterior roof cap coating system is a multiple coat enamel coating system. The coating is in poor condition overall, it is beginning to chalk and fade and there is loss of gloss. Surfaces have faded due to exposure to ultraviolet light, which is a normal occurrence for an exterior coating system. There are numerous coating failures found. Primary method of deterioration is spot coating failures to the substrate.

8) Spot coating failures with rusting.

Lift the digester cover and move to a location on site where blast media can be contained and the plant can operate without interference. Remove the existing coating by water dampened abrasive blast cleaning to a commercial condition (SSPC-SP6), and apply a urethane system.

The coating system would consist of a full prime coat on the bare metal, a full coat of epoxy, followed by a two full coats of polyurethane. The polyurethane system offers excellent abrasion resistance with high gloss and sheen retention. The expected life of this system is fifteen years. The estimated cost to repaint is \$20,000.

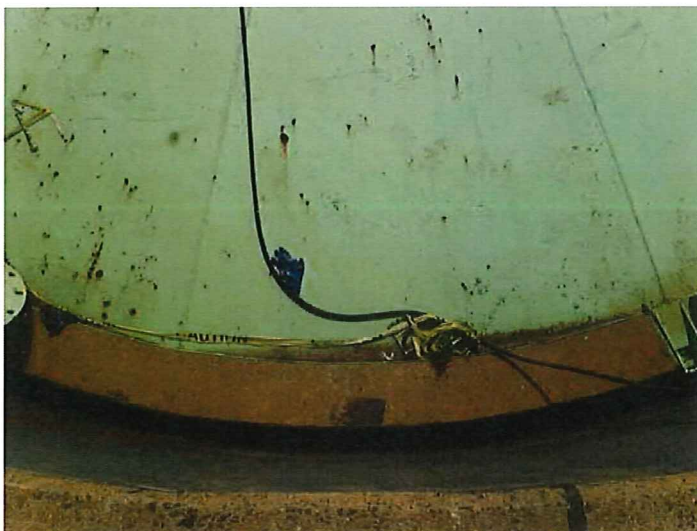
9) Same.

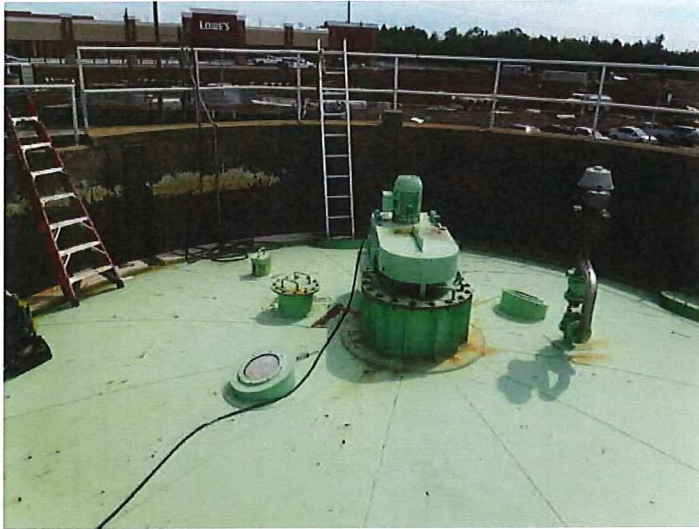
10) Same.

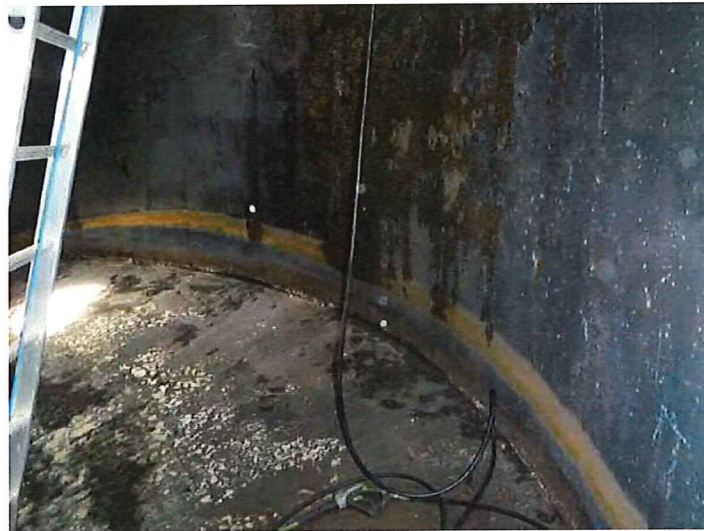
The interior sidewall concrete is coated with a polyurea system. The coating is in fair condition with delamination. The coating is in fair condition on the floor with delamination.

14) Coating is in fair condition on the floor and sidewall.

Remove the mineral encrustation and sediment on the surfaces by high-pressure water cleaning. Remove the loose and deteriorated concrete on surfaces back to solid concrete by abrasive blast cleaning. Apply a plural component polyurethane coating system or polyurea system.

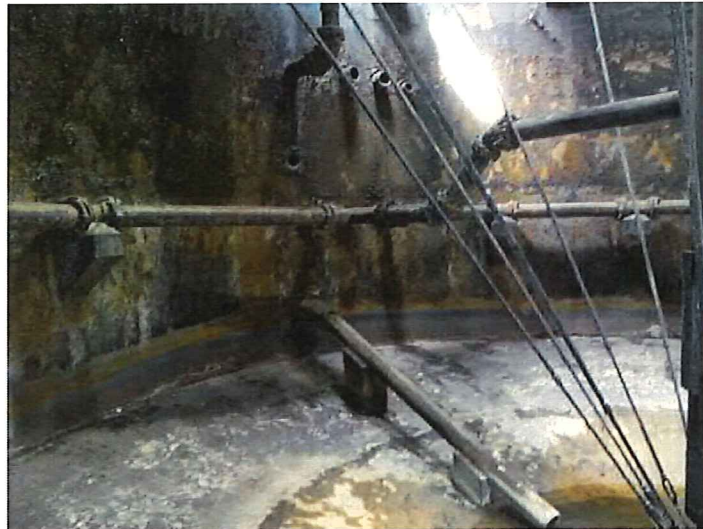
There is piping on the interior of the tank that are connected to the sidewall and roof cap. The piping is in good condition but the coating is in fair condition with delamination.

17) Interior piping coating is in fair condition.

Abrasive blast cleaning the interior piping, cylinder, and support rods to a near white metal (SSPC-SP10) condition and apply a cold tar epoxy coating system. The estimated cost to apply the three-coat epoxy system is \$12,000.

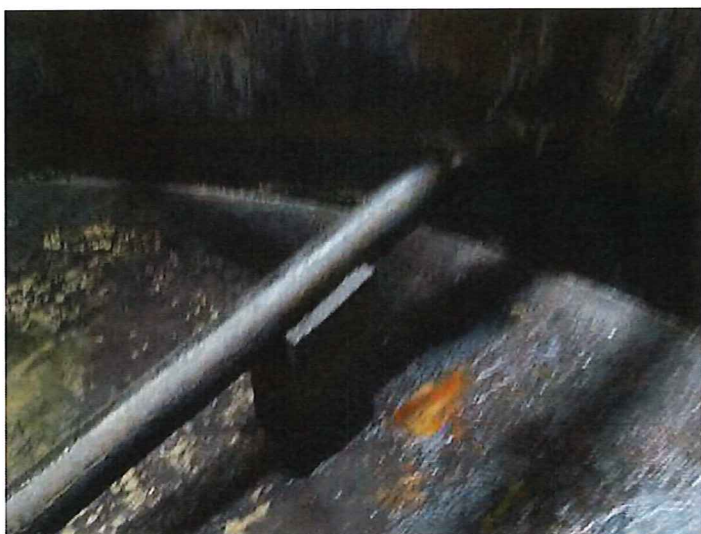
18) Same.

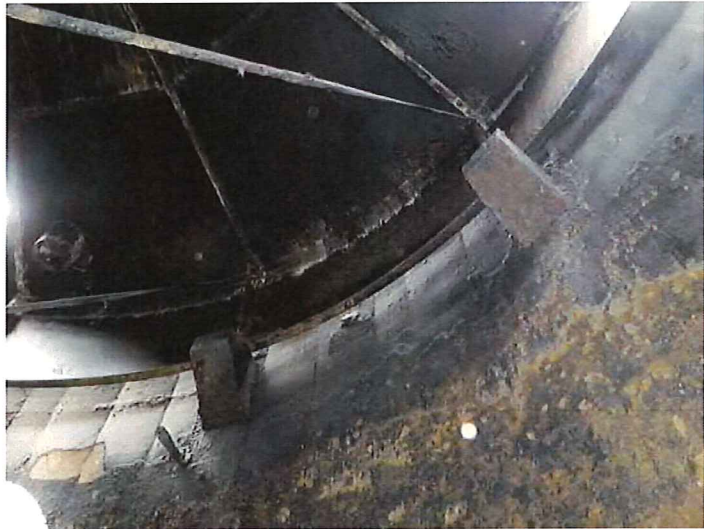
20) Sidewall coating with delamination.

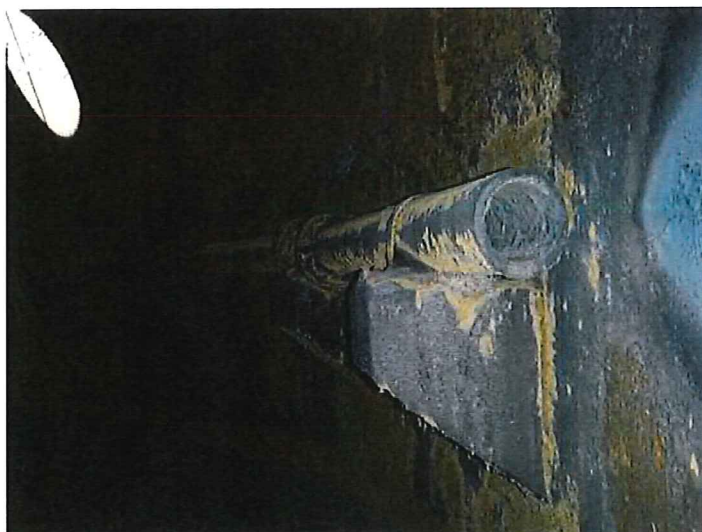
21) Same.

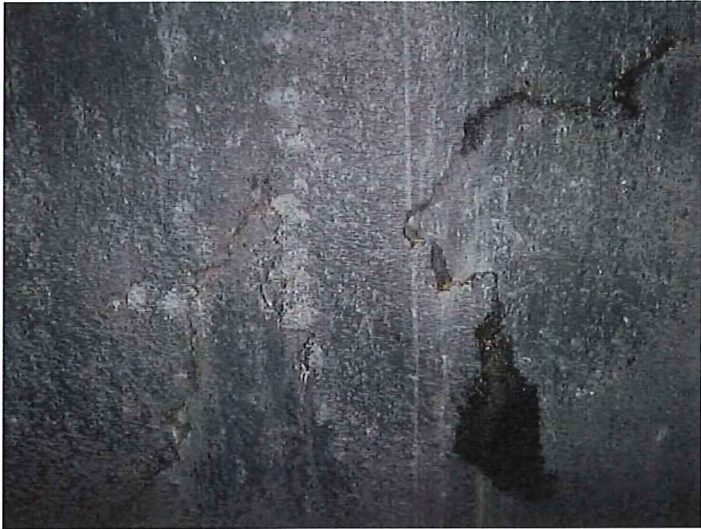
22) Same.

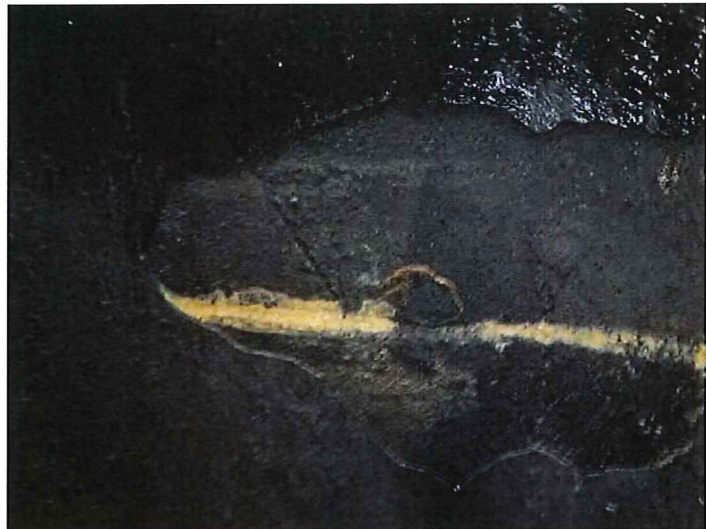
23) Same.

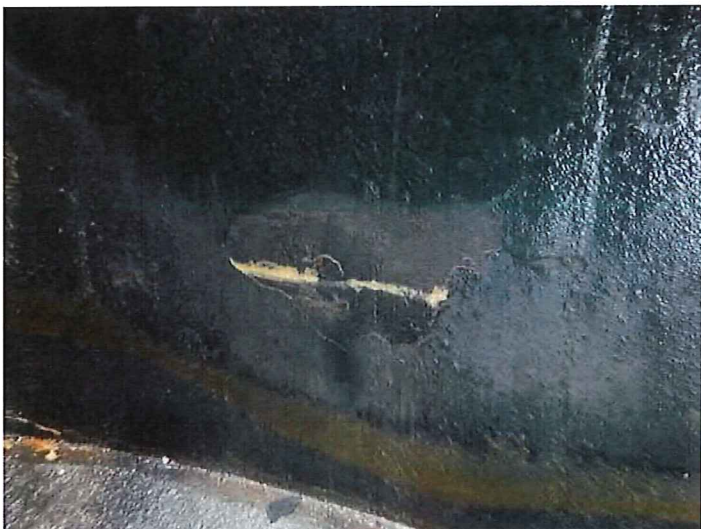
24) Same.

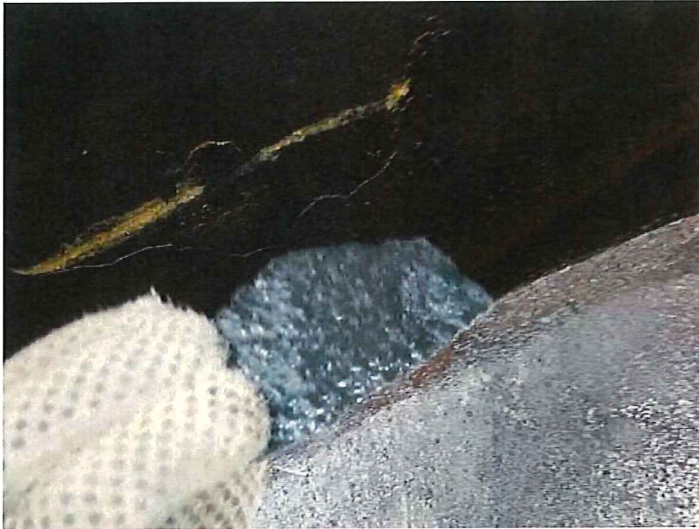
Describe coating: Brittle black 3/16 inch thick is cracking and delamination from concrete; blisters with liquid

25) Coating is brittle.

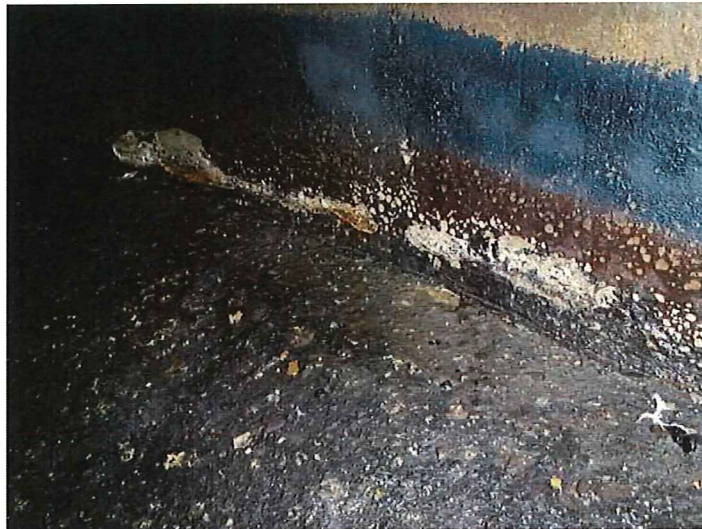
The concrete sidewall is in good with slight spalling at the sidewall to floor connection. The floor structure is in good condition, no concrete deterioration present.

26) Minor concrete spalling at bottom of sidewall.

Remove damaged concrete by cutting around the spalled areas to sound concrete, chipping out the loose concrete and repair the spalled sidewall areas with a mortar repair system. The estimated cost is \$2,000.

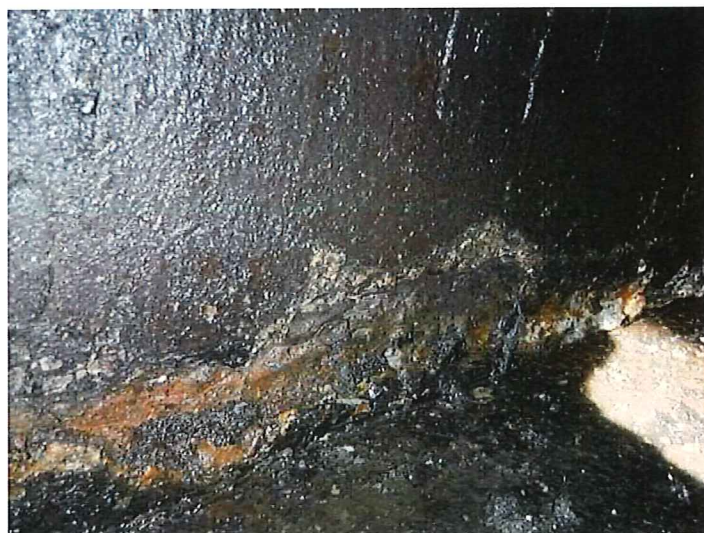
27) Same.

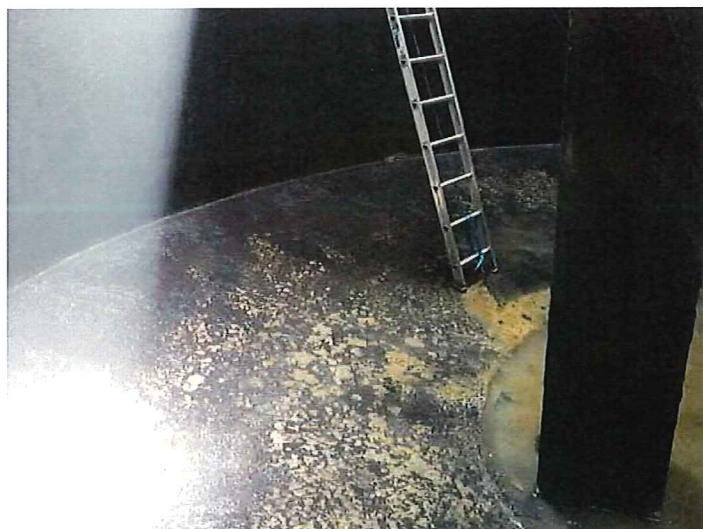
30) Floor coating with delamination.

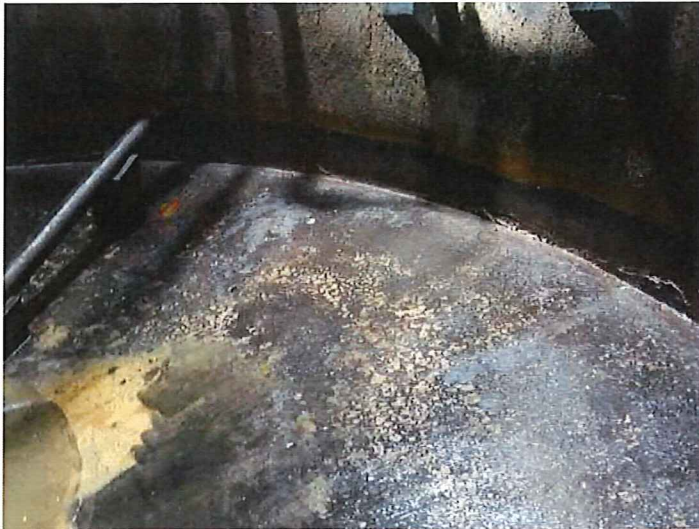
31) Same.

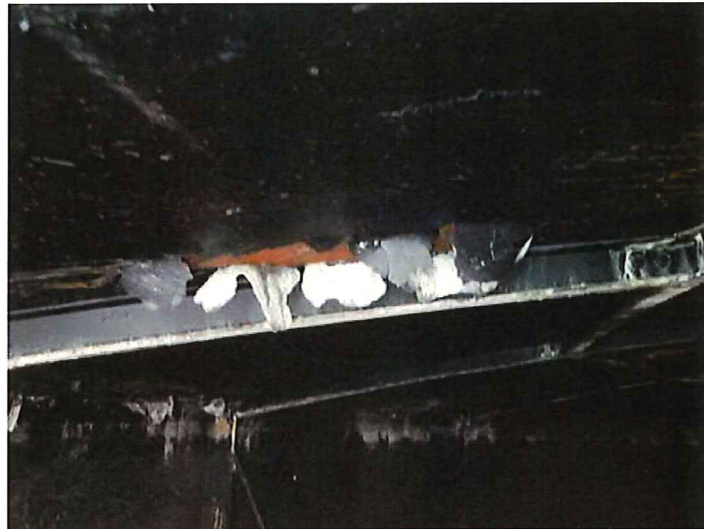
The wet interior roof cap coating is a coal tar epoxy system. The coating is in fair condition with deterioration in the form of spot coating failures and delaminated topcoat. Many coating failures were found on the cap stiffeners.

32) Interior roof cap with coating failures.

Remove the coating system by abrasive blast cleaning the metal to a near-white metal (SSPC-SP10) condition and apply an epoxy coating system. The estimated cost to apply the three-coat epoxy system is \$35,000.

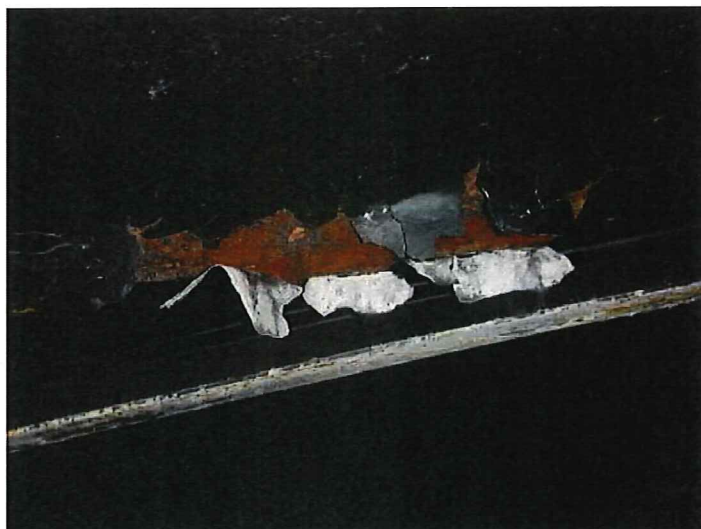
33) Same.
