Preliminary Maintenance Inspection

Wastewater Treatment Plant
Secondary Clarifier B

Leesburg, Virginia

Inspection Performed: August 17, 2016
Report Prepared: September 19, 2016
Reviewed by Ira M. Gabin, P.E.: September 27, 2016

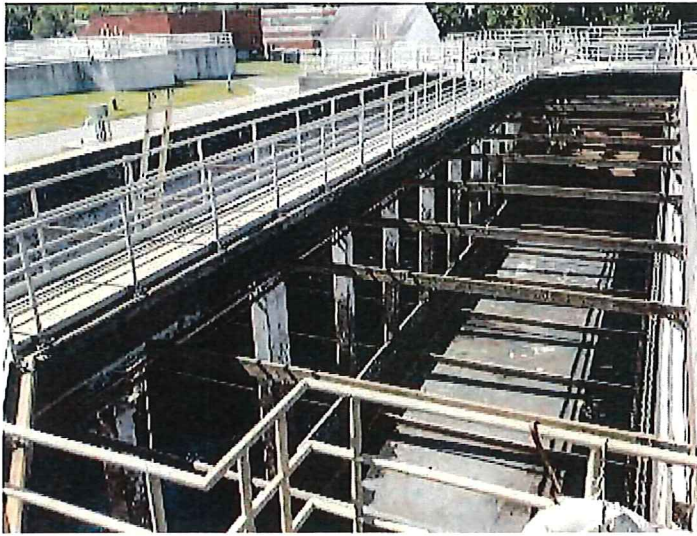
1) Secondary clarifier with catwalk and support steel.

Abrasive blast clean the catwalk steel support beams to a near white metal (SSPC-SP10) condition and apply an epoxy polyamide coating system. The estimated cost is \$15,000.

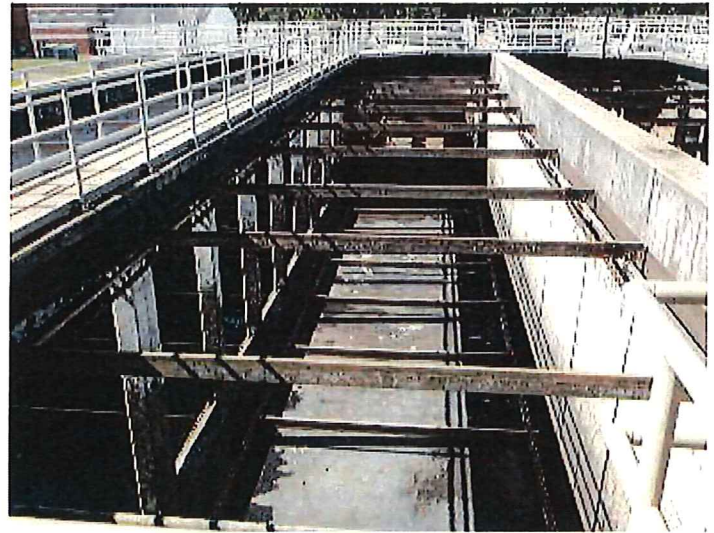
2) Same.

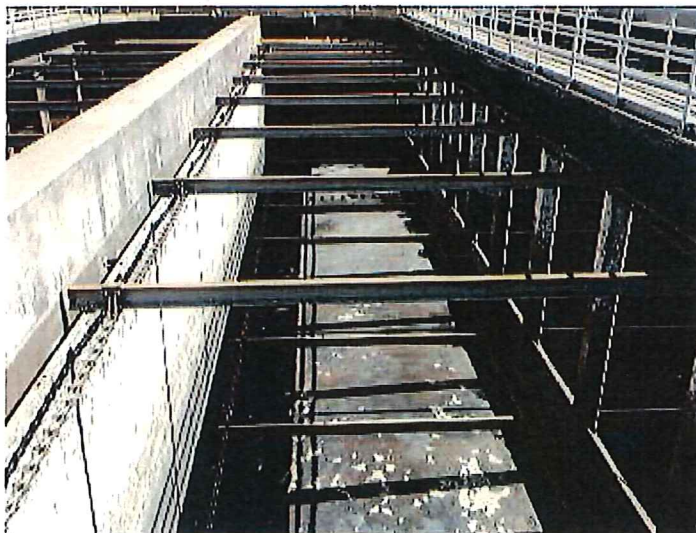
3) Same.

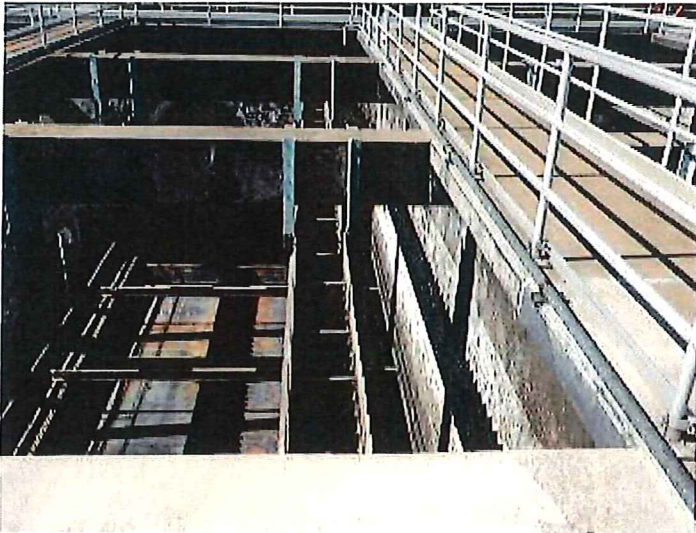
There are launders that runs across the clarifier at the high water line. The launders are in good condition and made out of fiberglass with triangle weirs. The weirs are intact and in good condition.

4) Fiberglass launders with weirs.

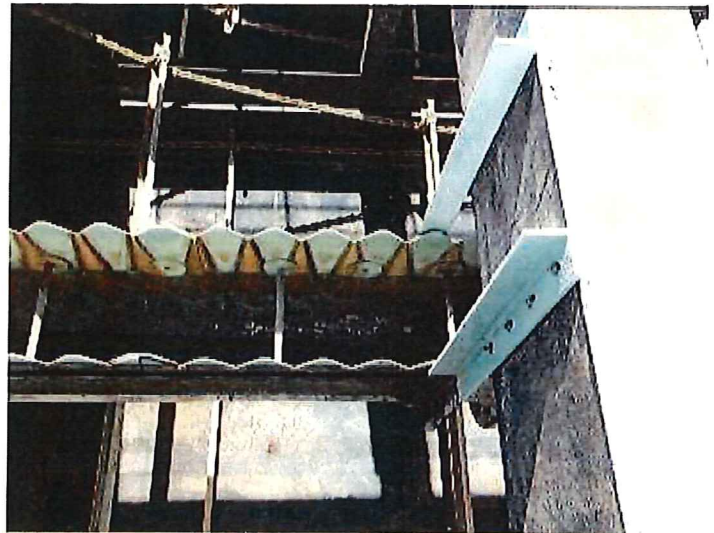
5) Same.

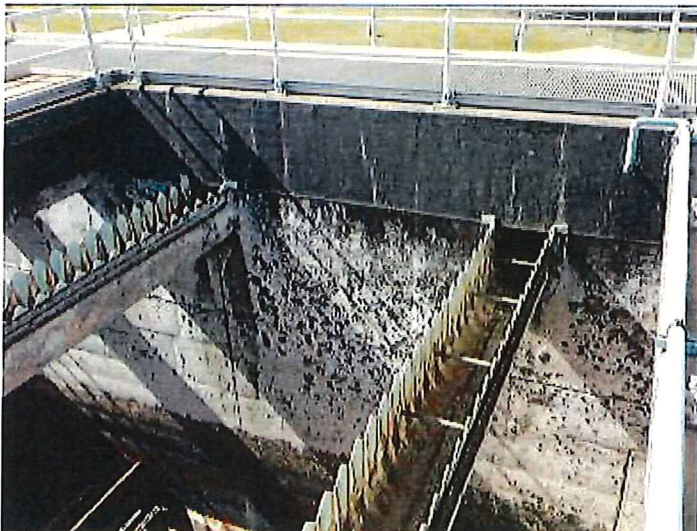
6) Same.

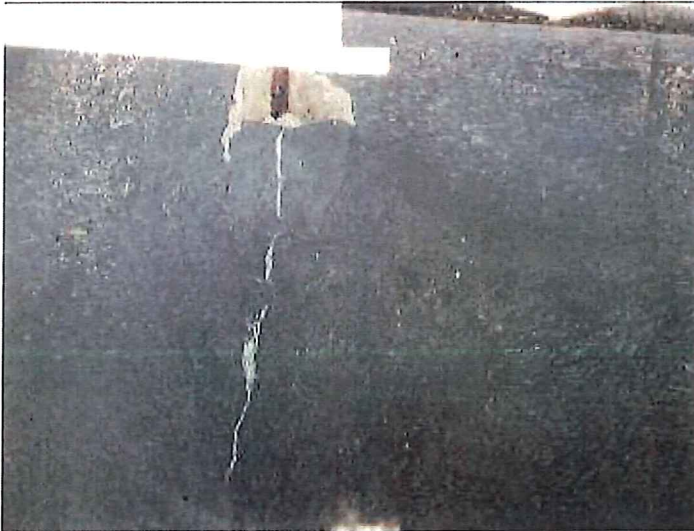
The concrete walls are in good condition below the high water line and in good condition above it. A few cracks are present. They are tight with the edges in place. The cracks are vertical with slight efflorescence on the cracks. One area of spalling is occurring at the top of the sidewall with rebar exposed. The concrete is cracked around the deteriorating rebar and it is moderately corroded.

7) Cracking and spalling at top of interior sidewall.

Remove damaged concrete by cutting around the spalled areas to sound concrete, chipping out the loose concrete and repair the spalled sidewall areas with a mortar repair system. Abrasive blast clean the rebar and apply an epoxy system. The estimated cost is \$1,000.

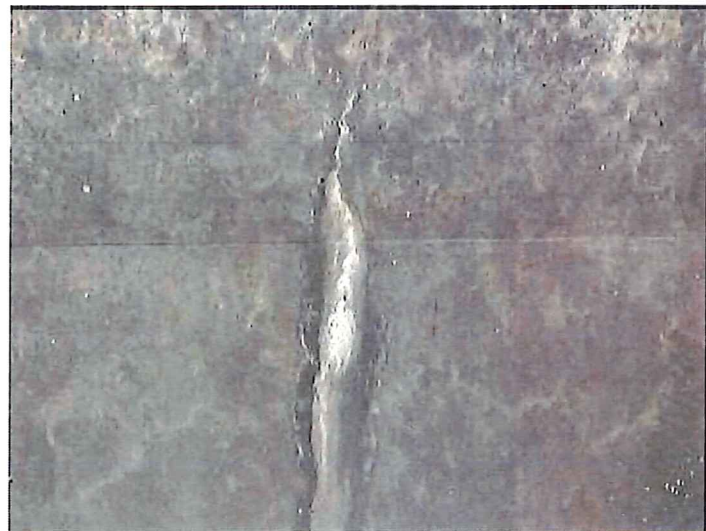
8) Cracking on interior sidewall.

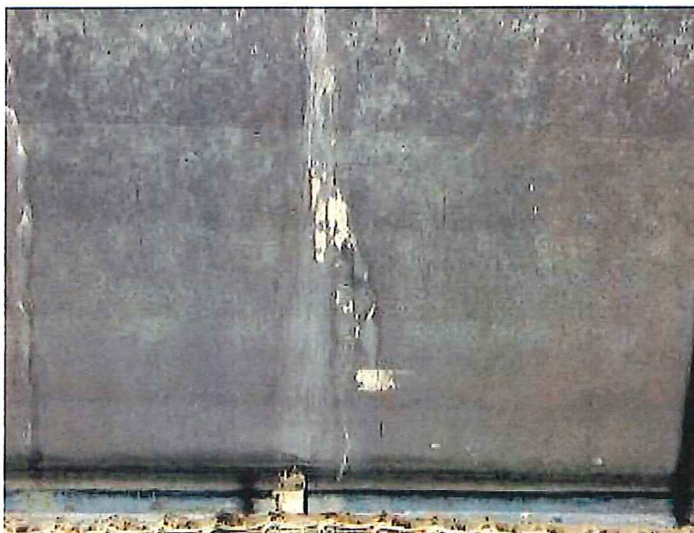
9) Interior wall cracking and coating delamination.

Remove the mineral encrustation and sediment on the surfaces by high-pressure water cleaning. Remove the old coating system and create a profile in the concrete by abrasive blast cleaning. Apply a plural component polyurea coating system.

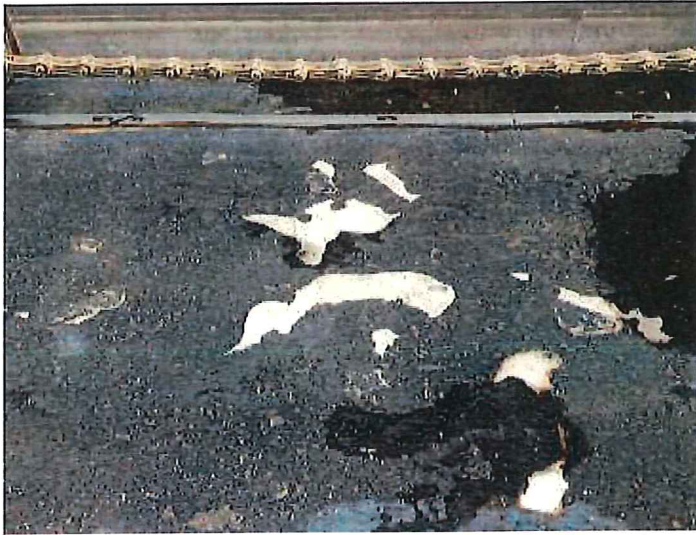
The walls and floor are coated with an elastomeric coating system. The coating is in poor condition overall. The sidewall and floor coating has extensive deterioration in the form of delaminated topcoat and blisters throughout most areas.

10) Coating failures on the floor.

The plural component system has good adhesion and a fast cure time. It is applied in one coat. Within several days of completing the cleaning and blasting, the tank can be returned to service. The estimated cost to apply the plural component urea system is \$150,000.

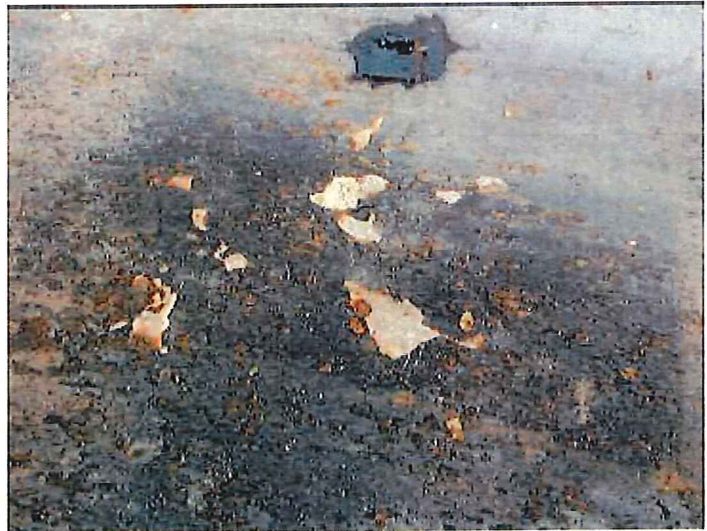
11) Same.

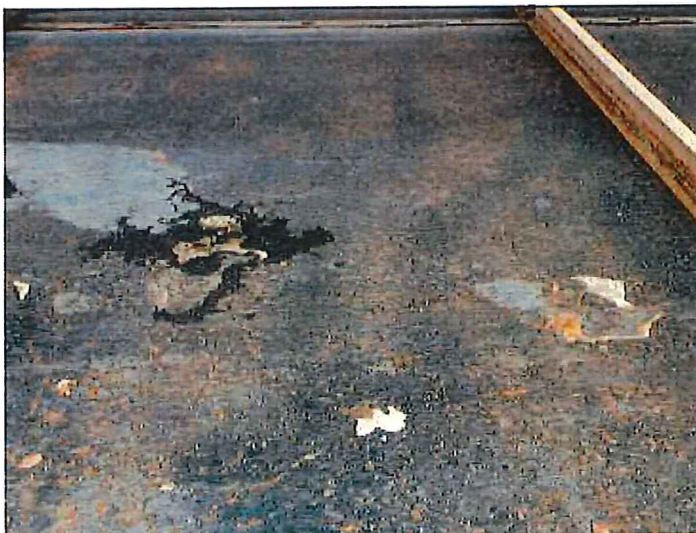
12) Same.

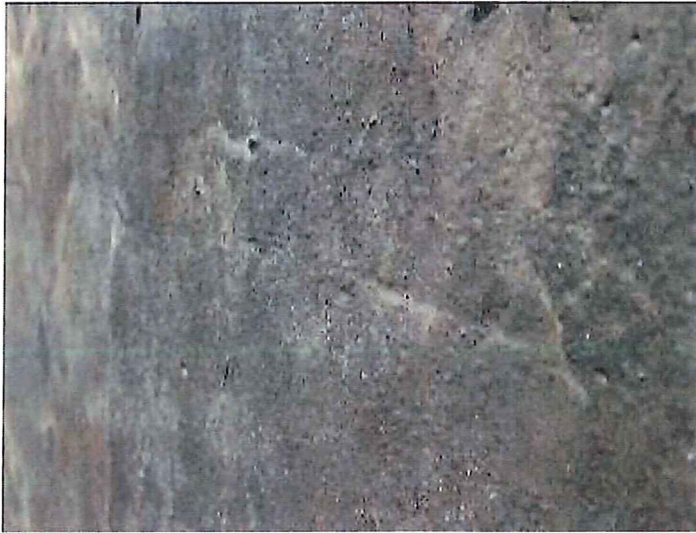
13) Coating blistering on interior sidewalls.

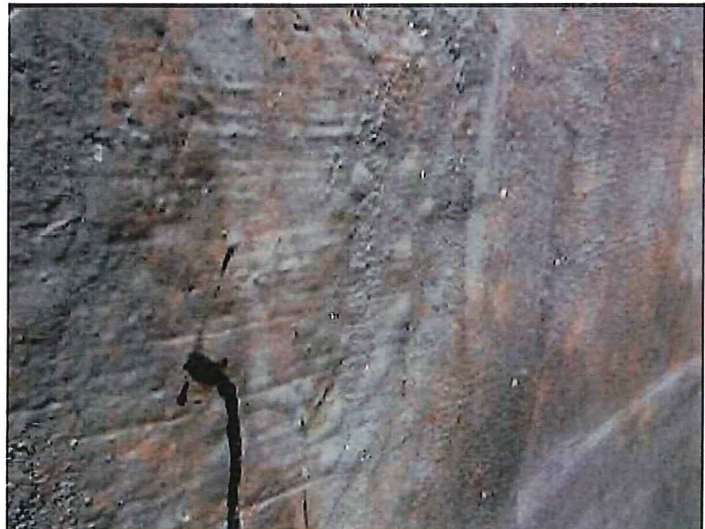
14) Same.

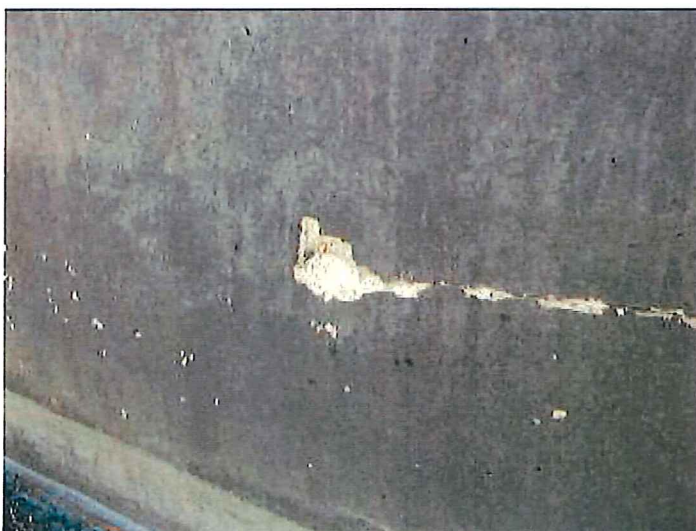
15) Coating delamination on interior sidewalls.

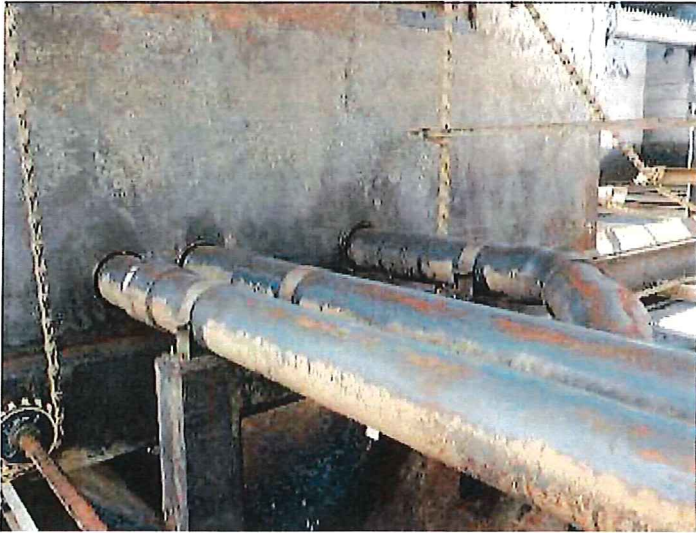
16) The piping is in good condition.

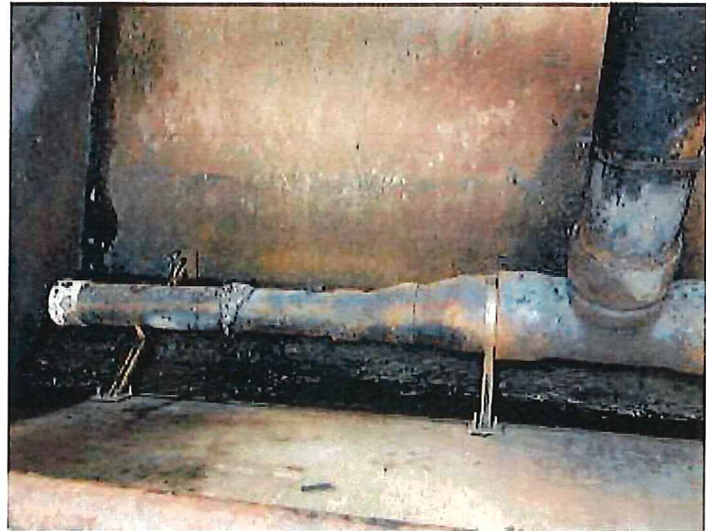
17) The corner diffusers are in good condition.

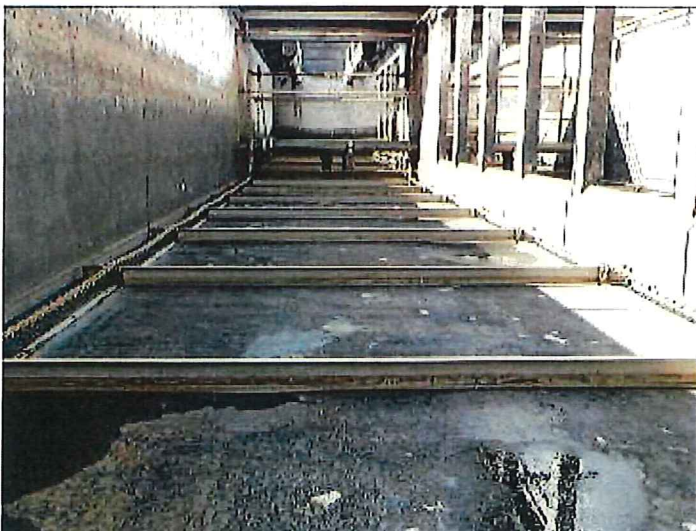
18) The sludge scrapers are in good condition.

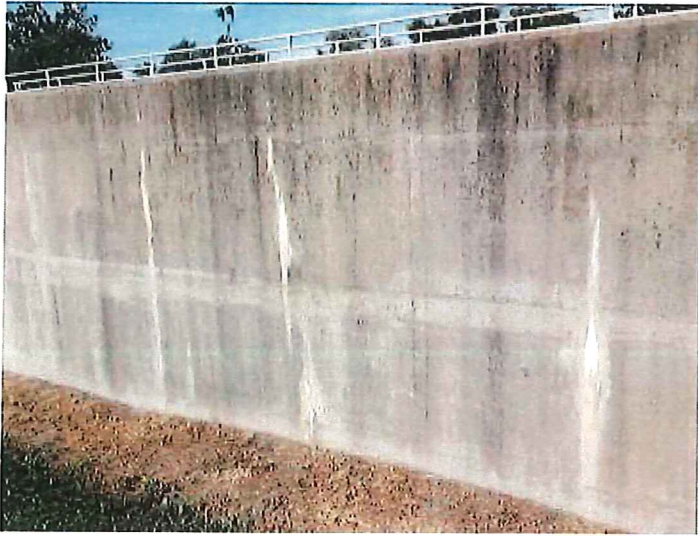
Approximately 5 to 10 feet of the exterior walls are exposed. There was no major damage noted on the exterior concrete. Cracking is present at random locations. The cracks are tight with the edges in place. The cracks are vertical and horizontal with slight efflorescence on the cracks.

19) Exterior concrete with cracking and efflorescence.

Clean out cracks where efflorescence is present by routing the crack to a u-shape and fill with a mortar repair system. The estimated cost is \$3,000.

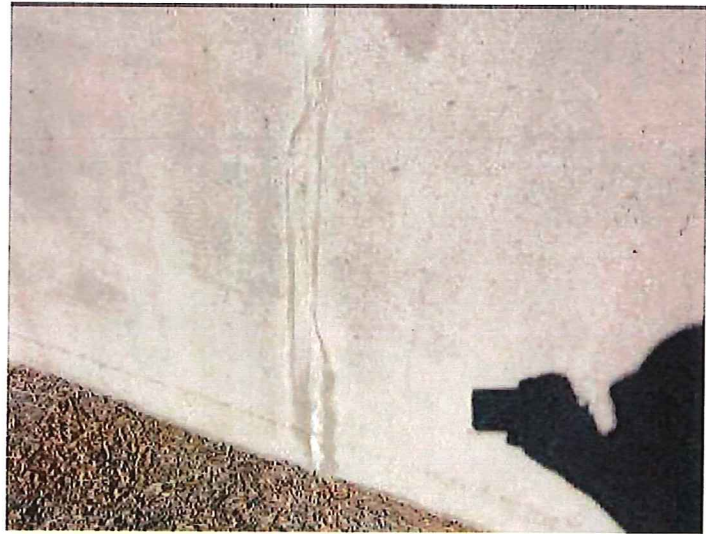
20) Same.

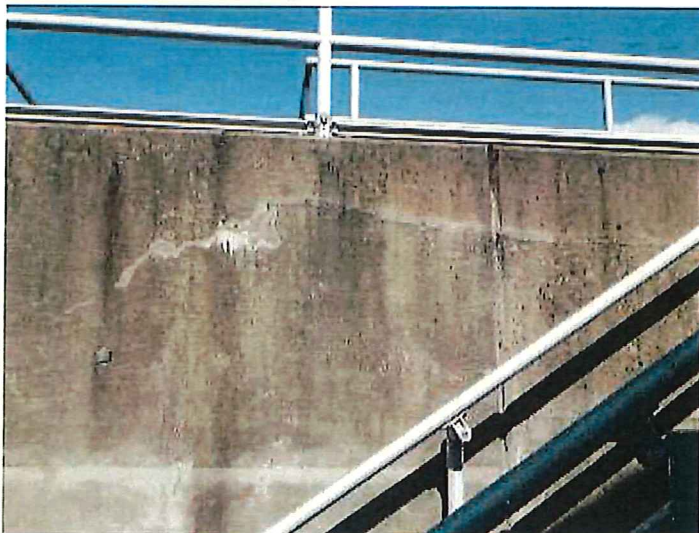
21) Same.
