Re: 1,250,000 Gallon Equalization Basin A Storage Tank
Preliminary Maintenance Inspection

Preliminary Maintenance Inspection

1,250,000 Equalization Basin A

Leesburg, Virginia

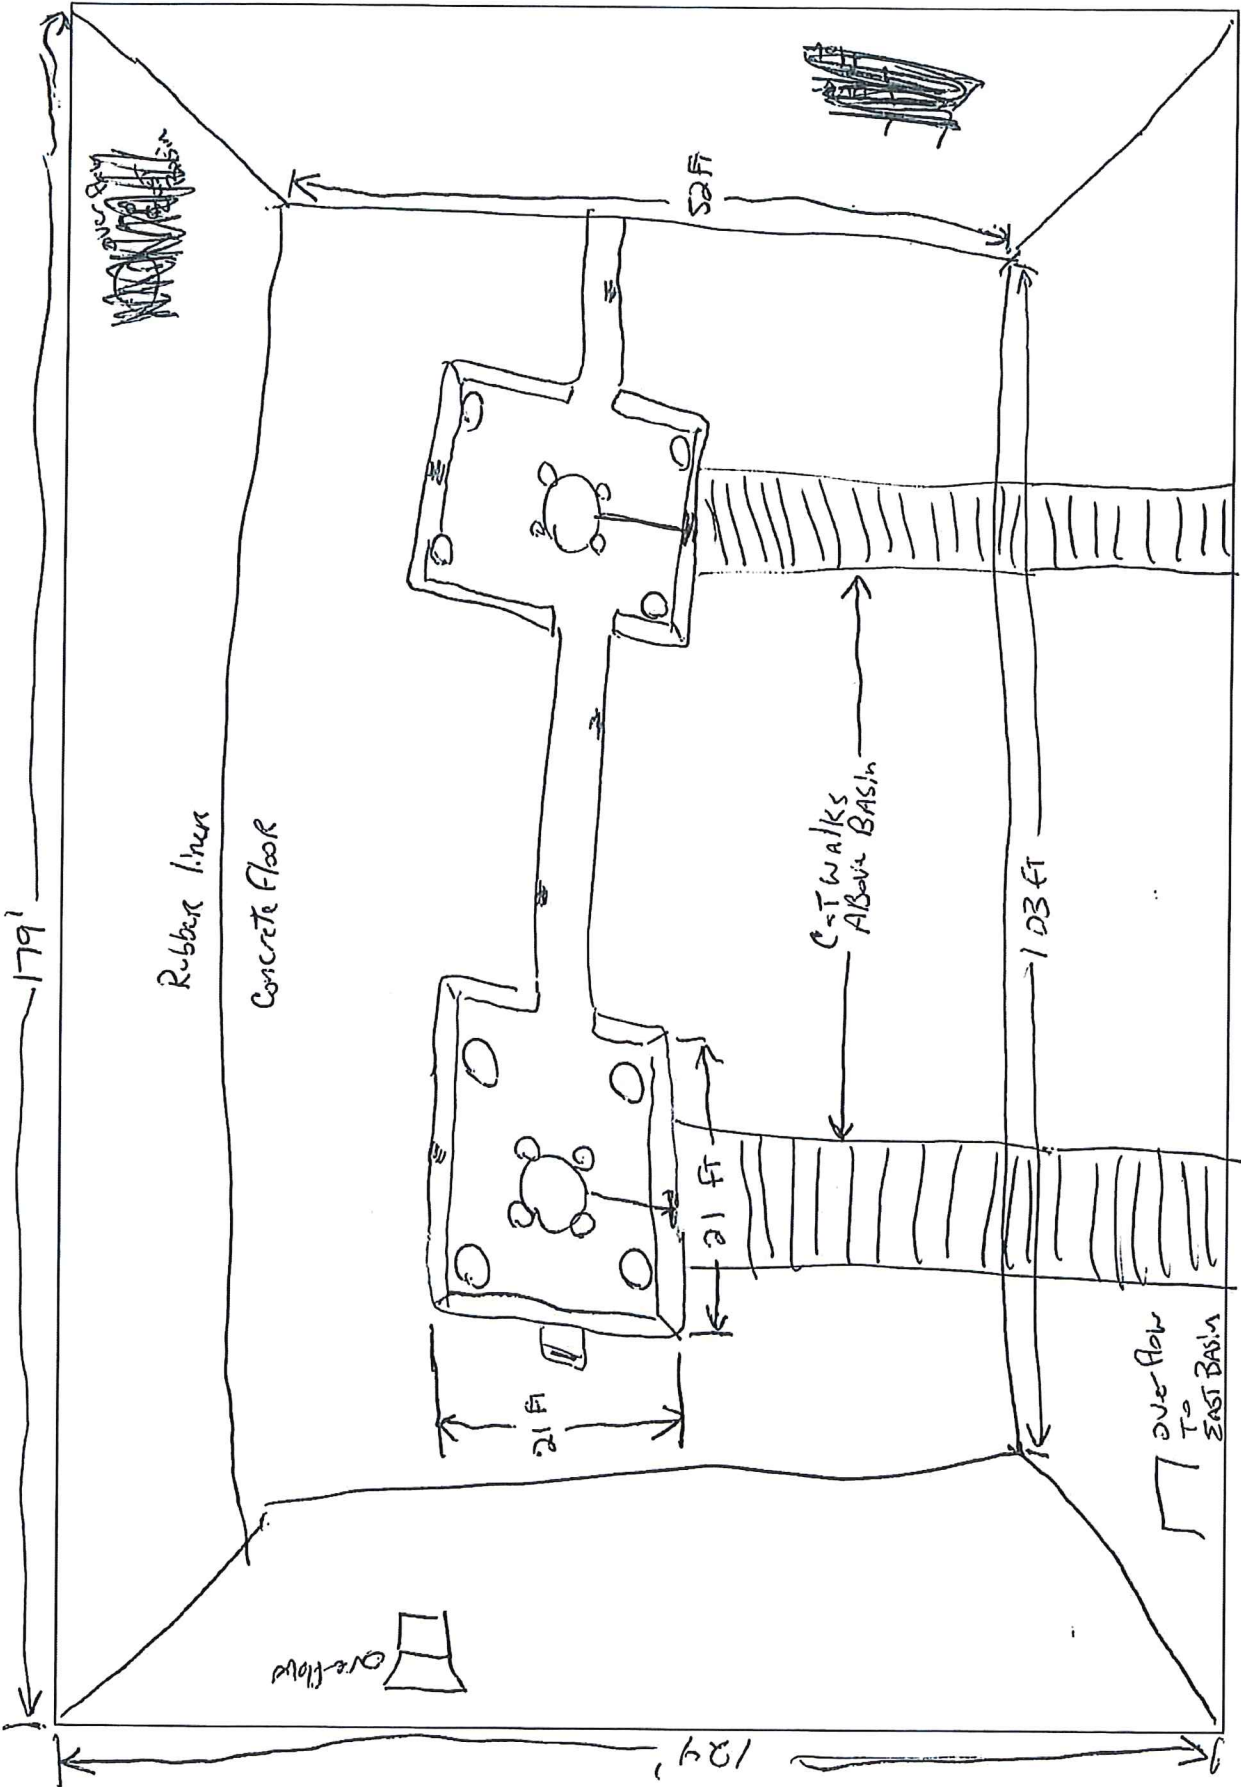
SECTION: Sketch cracking (label side if rectangle shaped, label quadrant if round, sketch markers such as manways,

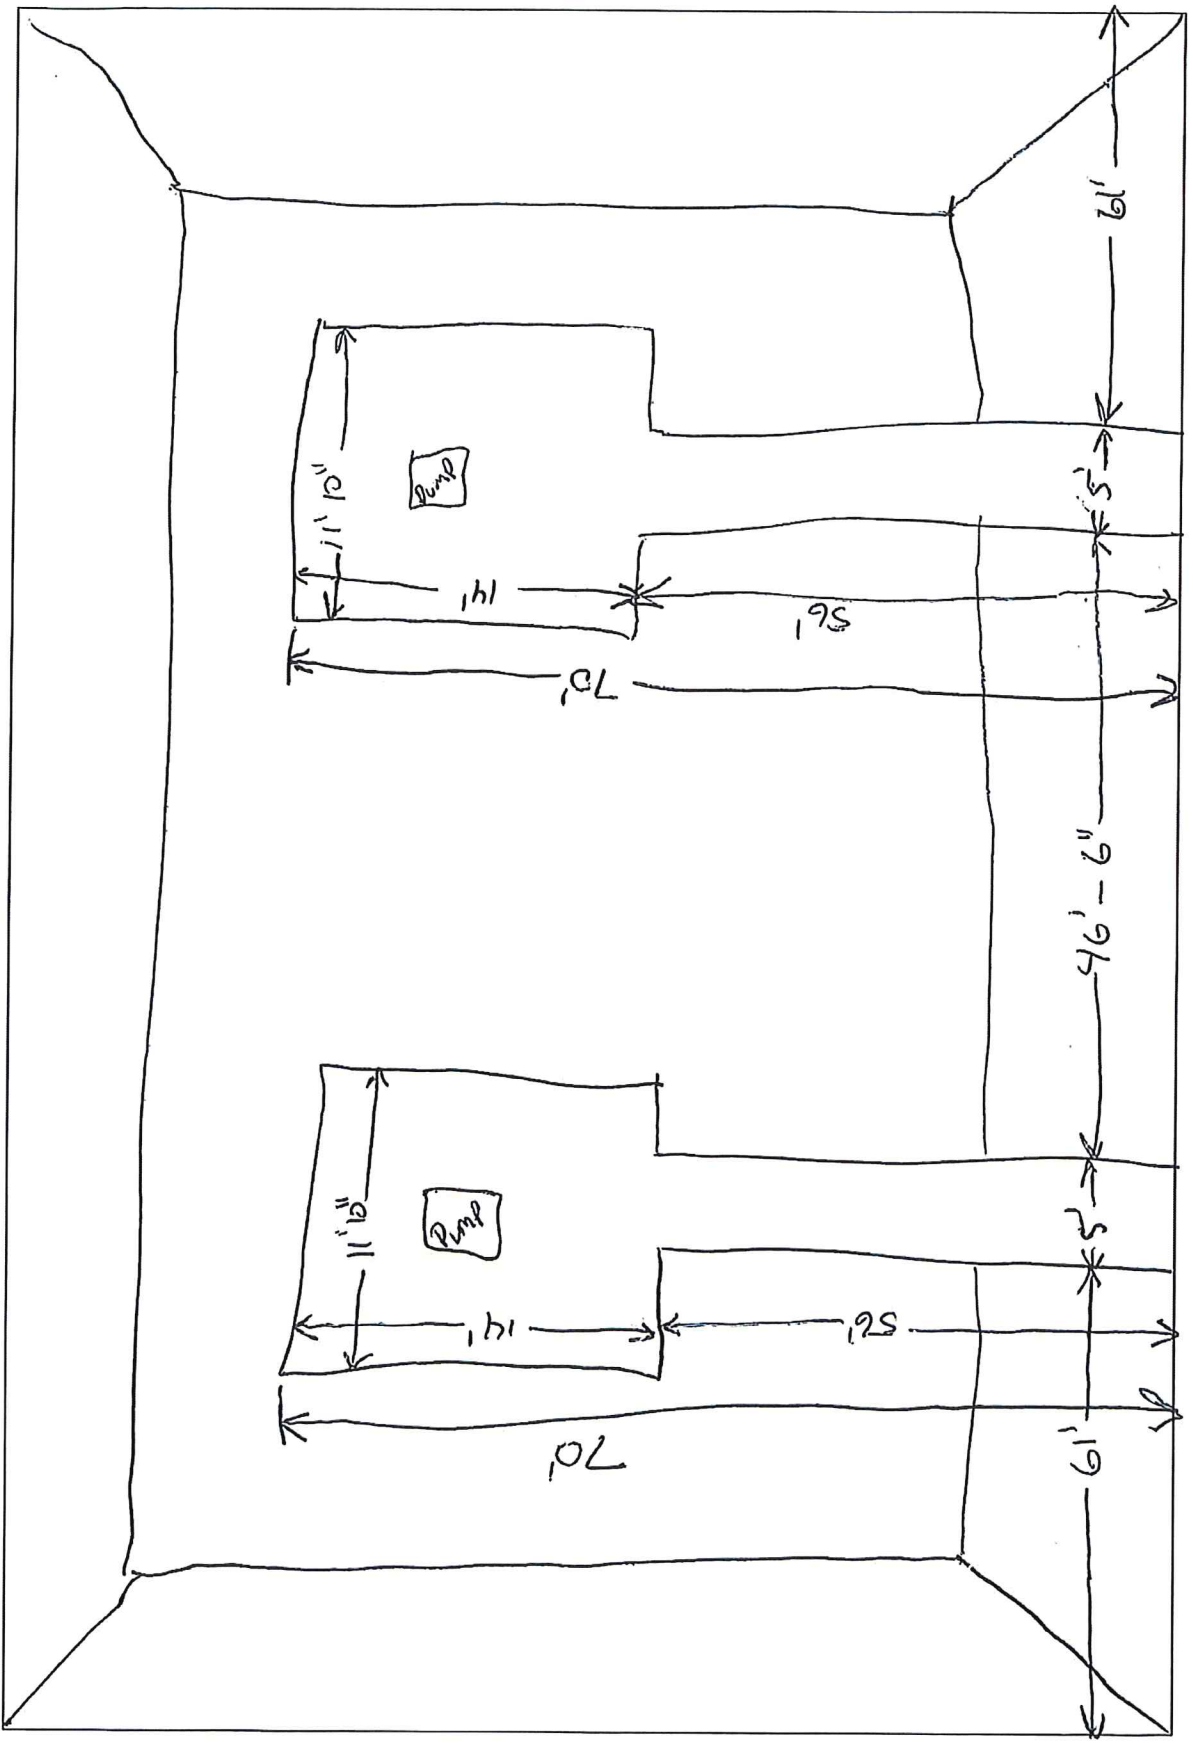
Basin A West

SECTION: Sketch cracking (label side if rectangle shaped, label quadrant if round, sketch markers such as manways,
